THE BETHLEN CASTLE IN BOIU-ȚOPA*

Letiția Cosnean**

Abstract: The Bethlen castle in Boiu-Țopa, built at the beginning of the seventeenth century, extended and reconditioned during the eighteenth and nineteenth centuries by the Bethlen family (its Balasz-Blasius branch), is today in a state of ruin. Valuable fragments from the castle, important for the history of Transylvanian art and architecture (sculptured stone window-frames of Renaissance influence, a stone inscription with the Bethlen coat of arms, ornamental fragments of stucco and plaster) have disappeared gradually during the past twenty years because of improper use and dereliction.

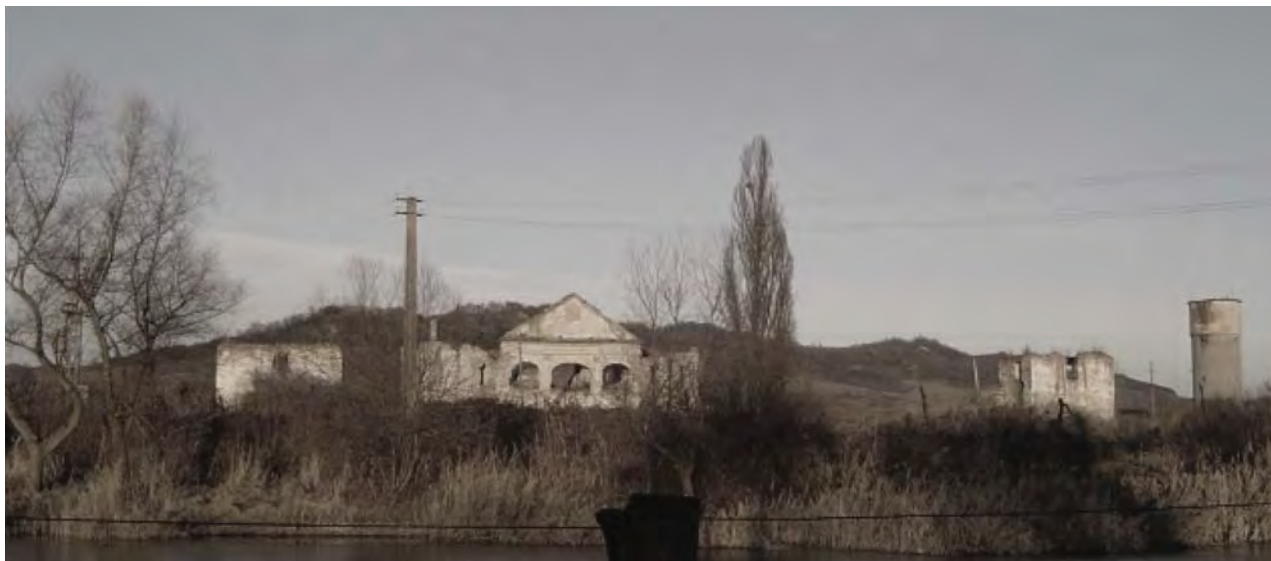
The building of the castle has been preserved until today as a ruin, while only two of the defence towers have survived from the fortified precinct (Fig. 4).

Fig. 4. Ruins of the Bethlen castle in Boiu-Țopa as of 2009.

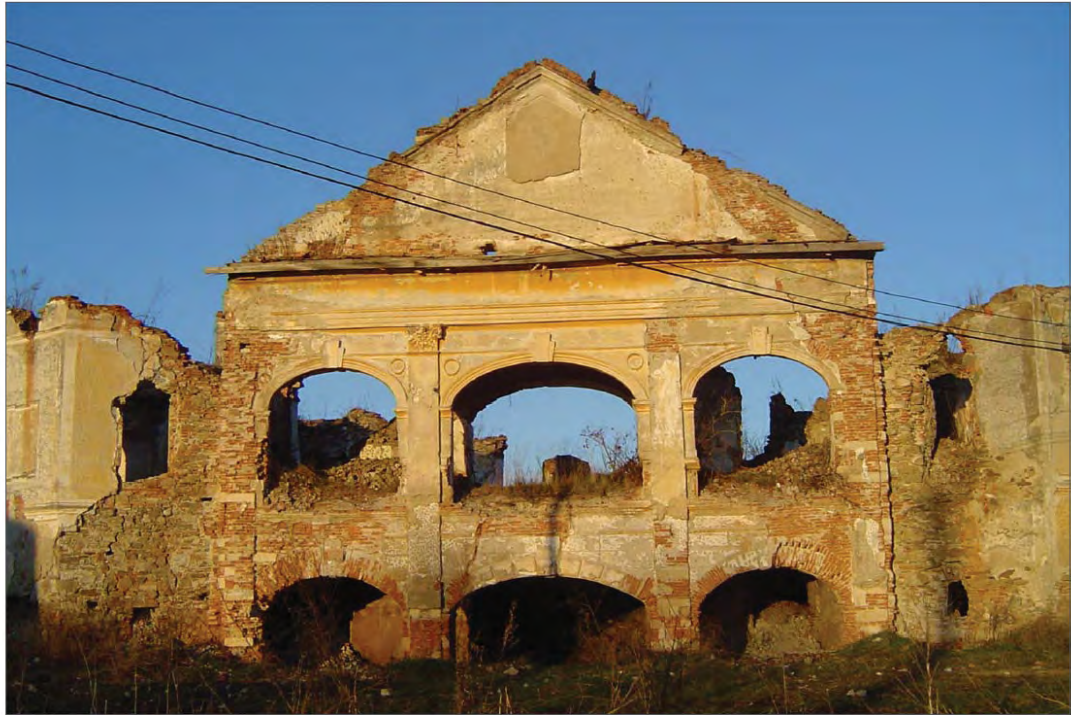
Fig. 5. *Spolia* on the castle's southern façade.

Moulded stones (P.1 and P.2) are located at the base of the pillar placed on the left side of the faade (Fig. 5).

Simple items (S.1-S.5), lacking any moulding, but having defining elements that can be determined (the dimensions of their sides, constructive details, traces from the finishing of the visible sides). Items S.1-S.4 are placed in the lower part of the left median pillar, while item S.5 is located as the base of the pillar in the right corner of the faade (Fig. 5).

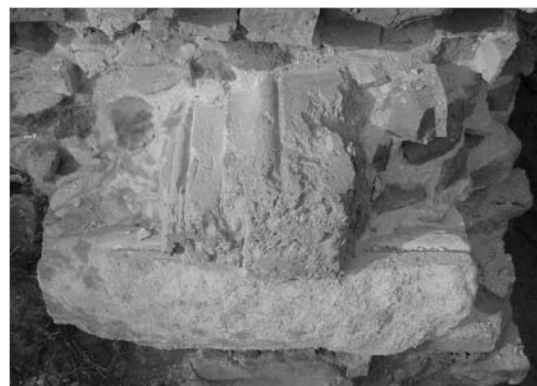
Fig. 6/1 Spolia with moulding P.1.

Item P.1, longitudinally placed in the masonry; its dimensions could be fully determined, thus: height: 21 cm, width: ca. 17-18 cm, length: 62 cm. The item is placed with its moulded side as bedding surface, below item P.2 (Fig. 6/1).

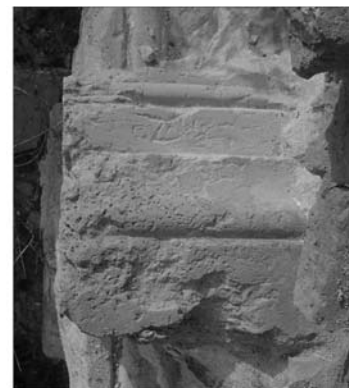
Fig. 6/2 Spolia with moulding P.2.

Item P.2, transversely placed in the masonry; only two of its sides could be measured: height: 25 cm, width: 17 cm. The item is placed with the moulded side as bedding surface, below the brick layer (Fig. 6/2).

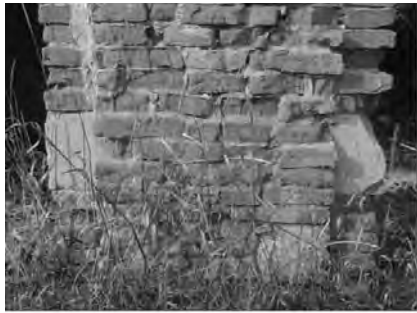
Items S.3 and S.4. They are placed at a distance from each other, but share the same dimensions (on the side that could be measured). Dimensions: height: 20 cm, width: 17 cm, length: inaccessible (Fig. 7/3).

Fig. 7/3 Simple *spolia* S.3 and S.4.
