SPACES WITH A SPECIFIC MORPHOLOGY OF MURAL PAINTINGS DEGRADATION: THE PORCHES OF ORTHODOX CHURCHES*

Dan Mohanu**

Summary: The degradation morphology and its evolution in the space of our medieval churches, indicates the existence of an architectural zone with a specific behavior due to the environment. Its impact has to be studied *before any other interventions* which should completely modify the transitory condition – outdoor / indoor – of the porch.

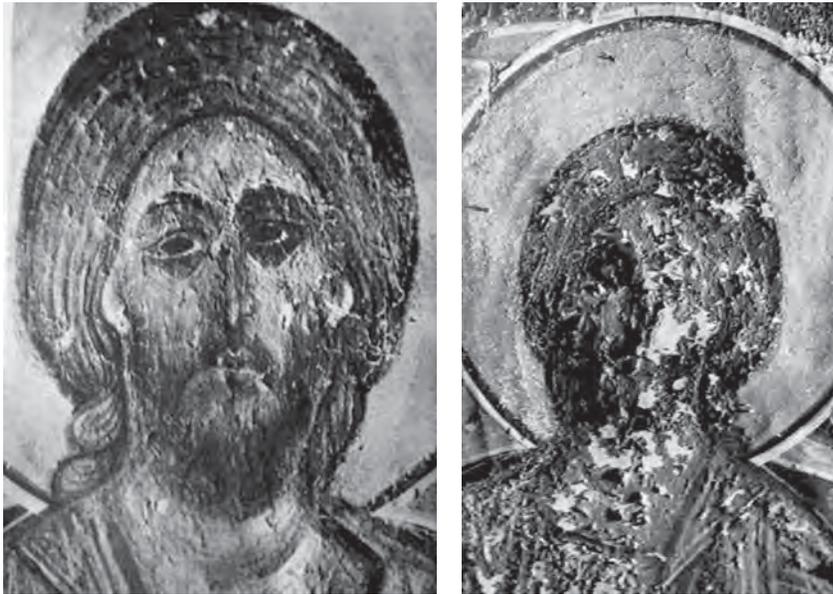
Fig. 2

a. Humor, porch, 1973. Examined in grazing light, the image of Jesus as Judge is just as other large areas of the Last Judgment, exposed to a process of defoliation. This was noticed for the first time.

b. Observed in 1993, the same detail, the head of Jesus as a Judge shows an equally extended process of defoliation, with visible loss of pictorial strata.

The third important observation for our study refers to the similarities of the morphology of the degradation of the mural painting from porches belonging to the same large family of medieval ecclesial Romanian architecture of the 16th-18th centuries (Figs. 2-3).

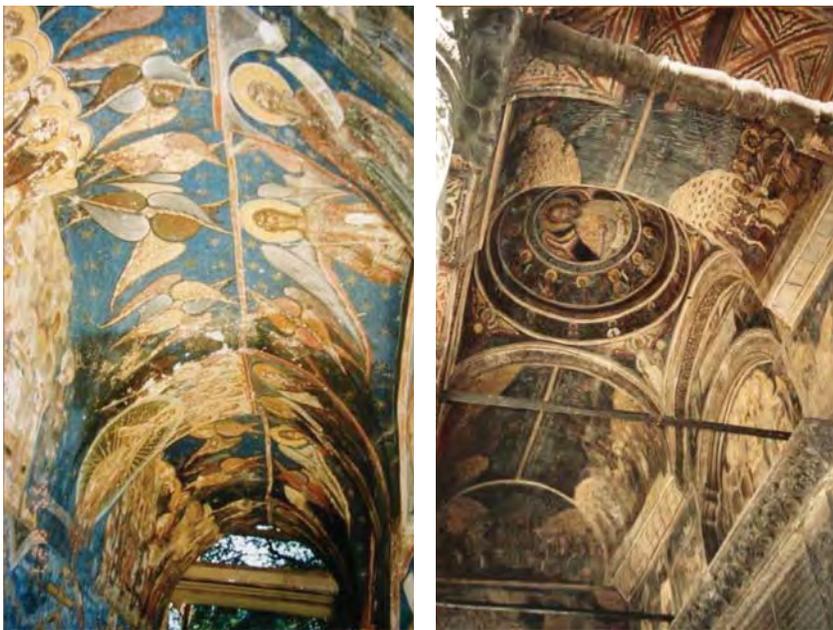
Fig. 3

a. Porch vault of Humor Monastery Church.

b. Porch of the church of Stavropoleos Monastery.

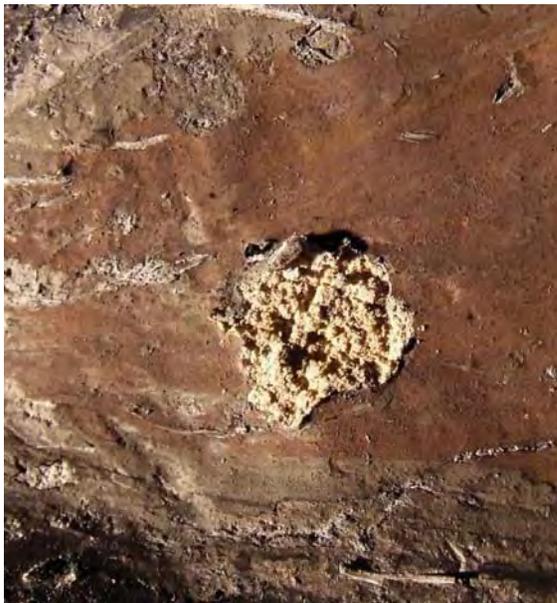
Fig. 4 a. Incipient signs of cohesion loss of the pictorial strata and of the support, point shape. The porch of the Humor Church.

1. *Point shaped craters* represent incipient forms of the de-cohesion process of the colour strata of mural paintings from the porch area. (Fig. 4). An evolution of their aspect is registered from the first forms hidden by the colour strata, dislocated together with a section of the support (*intonaco*), to the little gaps made by the

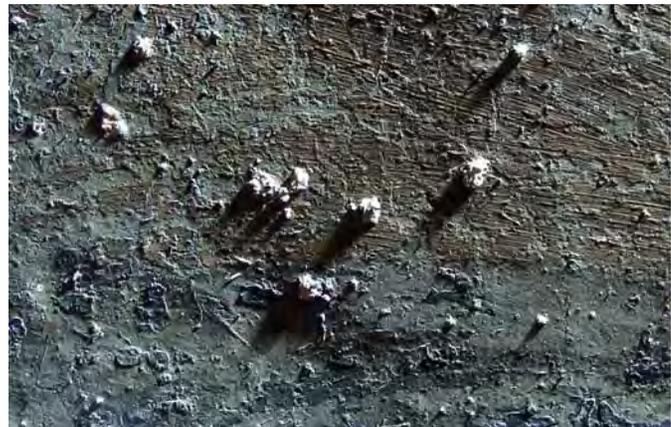
b. Point shape craters which appeared due to an older process of defoliation of the pictorial stratum. The porch of Doamnei Church.

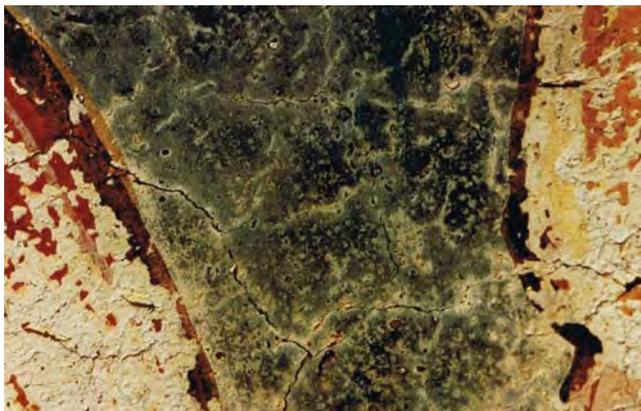
Fig. 5 a. Migration and re-crystallization of mobile salts with the shape of crypto fluorescent and point shape craters, as it appears on the pictorial stratum through the contraction cracks and micro cracks. An example is that of Humor Monastery porch.

expulsion of a small quantity of the support and the pictorial stratum. The pictorial materials are replaced by soluble salts (sulfate, nitrogen) which migrate from the inside of the building into the support and then re-crystallize on the pictorial level stratum (Fig. 5).

Hardly noticeable at the beginning the point-shape craters later turn into a symptom of de-cohesion of the pictorial stratum. The superficial presence of salts into little craters is anticipated by the presence of crypto-fluorescence. A description of the phenomenon was made by Șerban Angelescu in the 70s, procedure that would lead us to a treatment where the colour strata fixation is accompanied by the operation of soluble salt extraction. This is the quoted description: “Watching a detail of the colour surface, in an ex-foliation zone, small craters made by the re-crystallization of salt on the back of the pictorial strata are noticeable”.

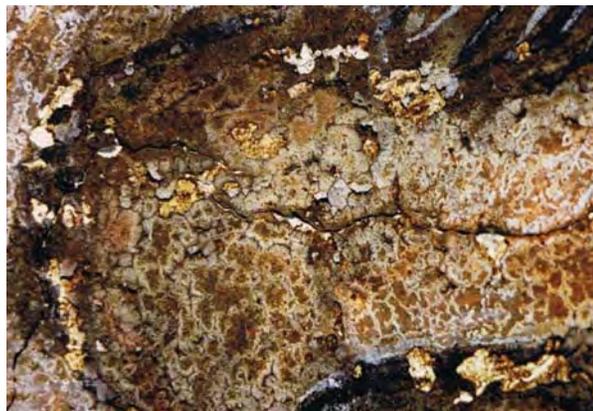
Fig. 5 b. Humor porch, another example of how the salty efflorescence appears in the micro cracks of pictorial stratum.

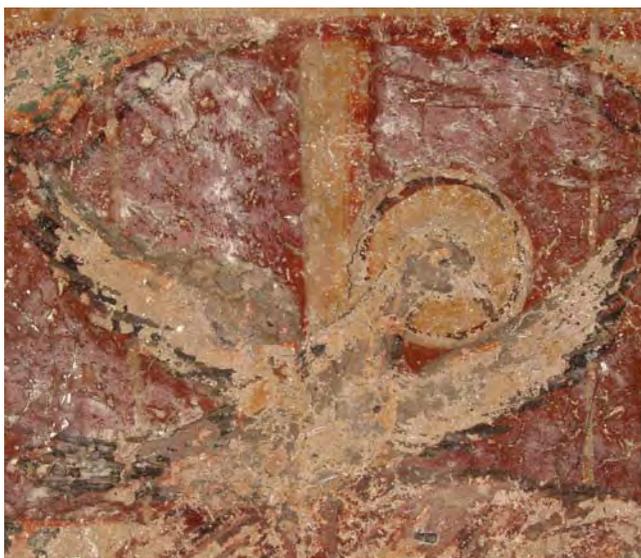
Fig. 6 a. Doamnei, Church porch. Last Judgment detail, Etimasia Throne, underlines the presence of salty veils on the pictorial stratum.

fragments of its support. Șerban Angelescu wrote in 1977: „Along the thin cracks of the support, a network of white halos and small points appears and extends gradually leading to a slow destruction”⁷

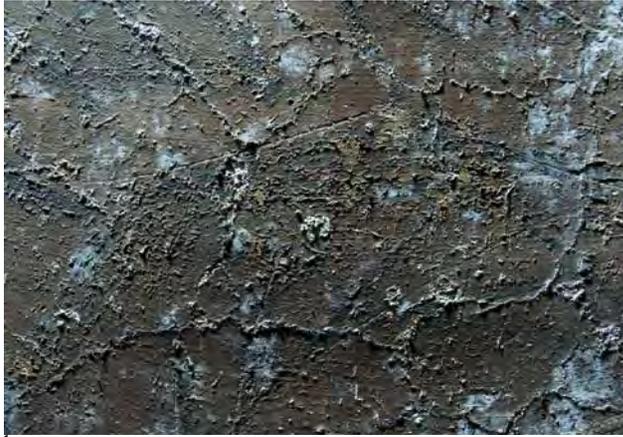
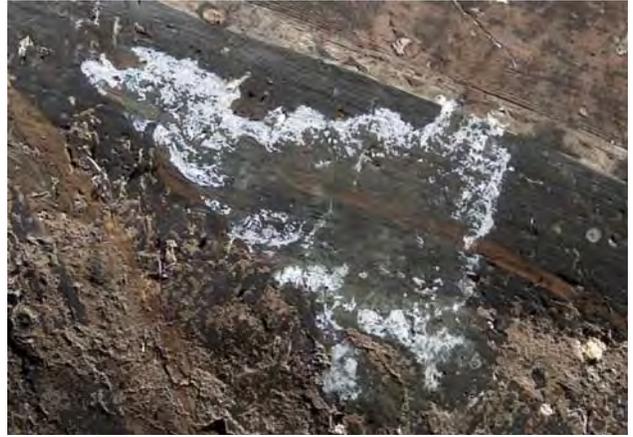
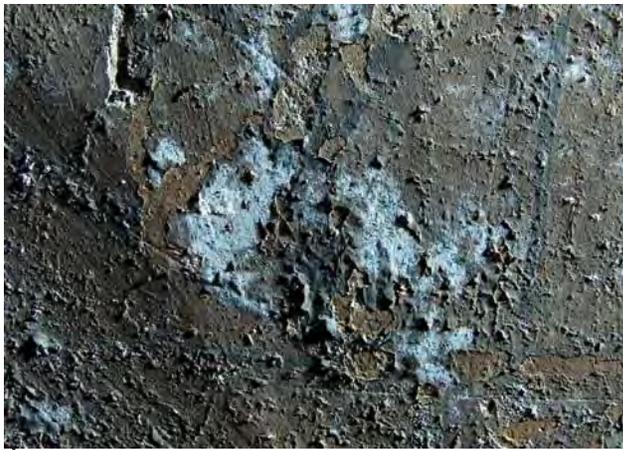
Fig. 6 b, c, d. Macro photos illustrating the process of the appearance of efflorescent crusts on the surface of pictorial stratum. The porch of Doamnei Church.

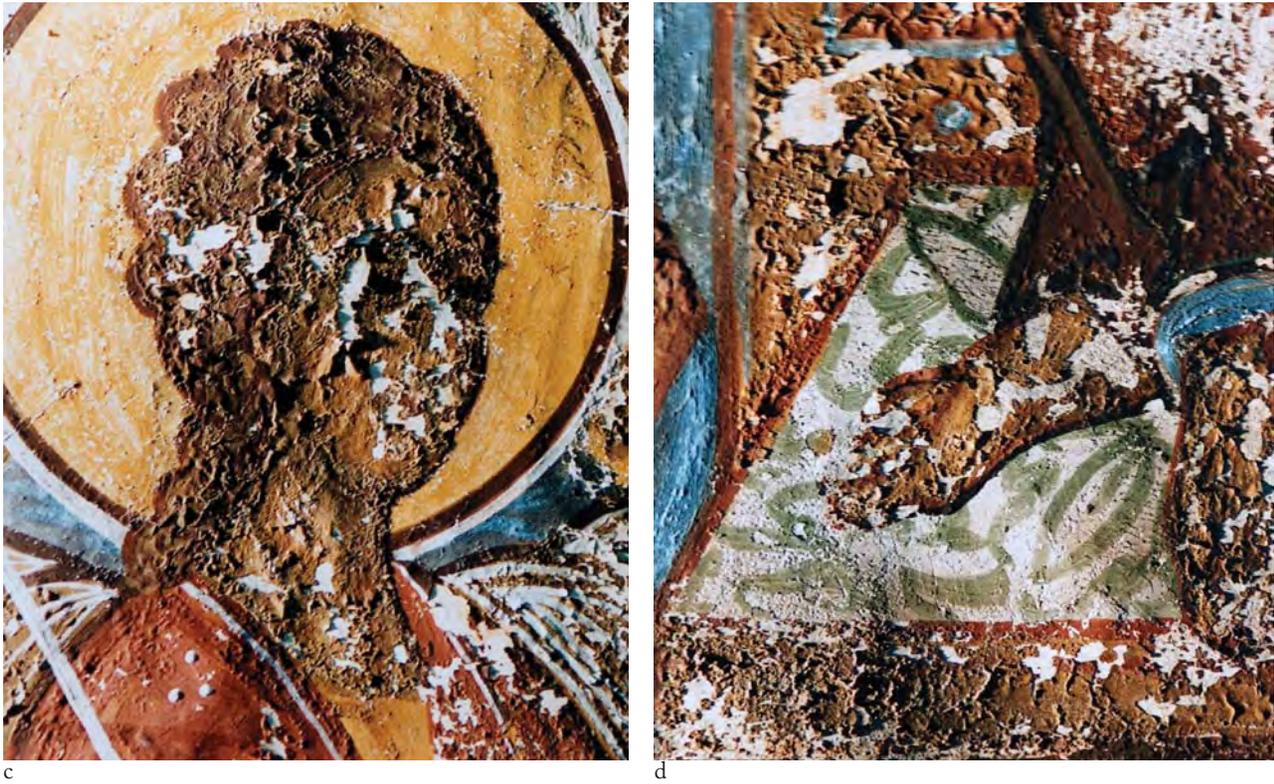
Fig. 7 c, d. Different morphologies of defoliation in the porch of Humor Monastery Church.

3. The last stage of the destructive action of salts consists of the fact that they appear on the surface, taking the shape of efflorescence *and salt crusts* (Fig. 7). From the veils of salts, easy to get rid off, to the salty crusts hardly soluble, there is an evolution marked by the progressive loss of colour stratum and part of the support.

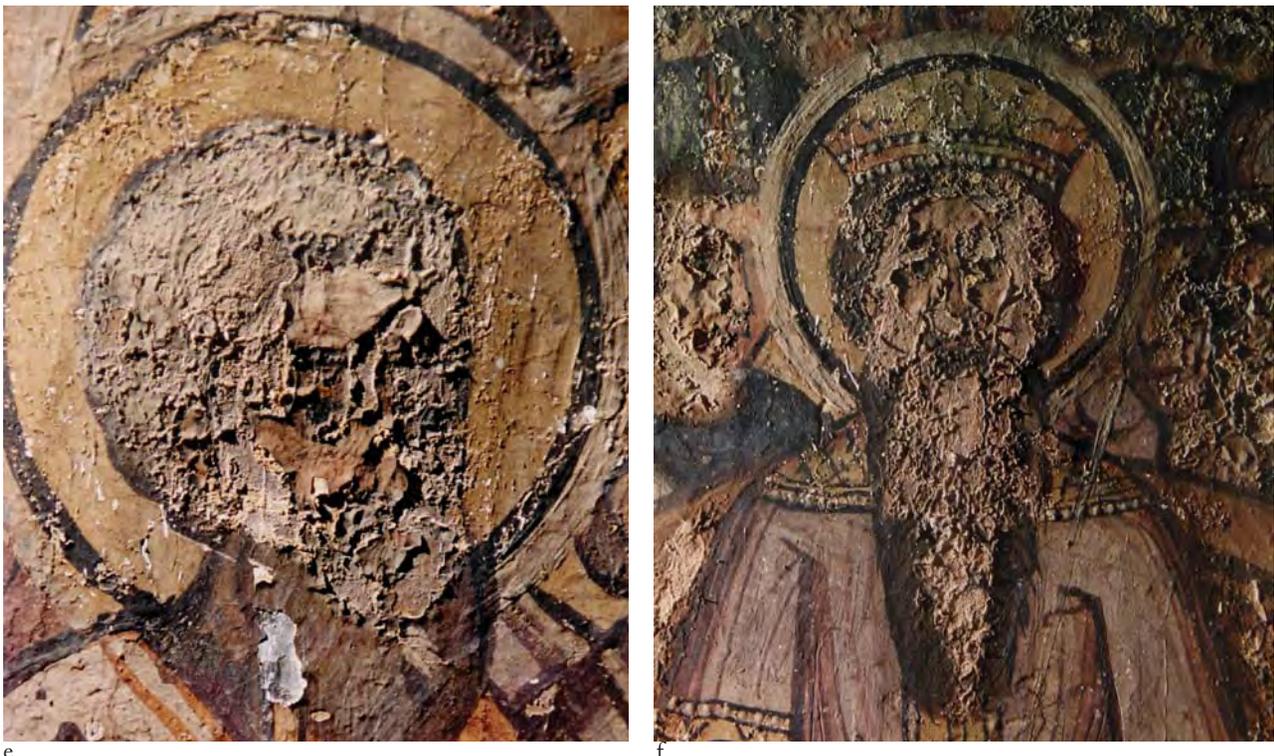
Fig. 7 d, e, f. Stavropoleos Church porch. Details in grazing light which makes visible the morphology of exfoliation: *scales, gonflations and covering slopes*, detached as gondola shape of the pictorial stratum.

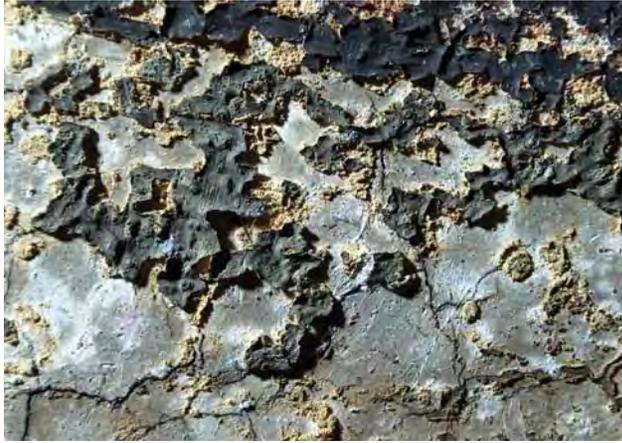
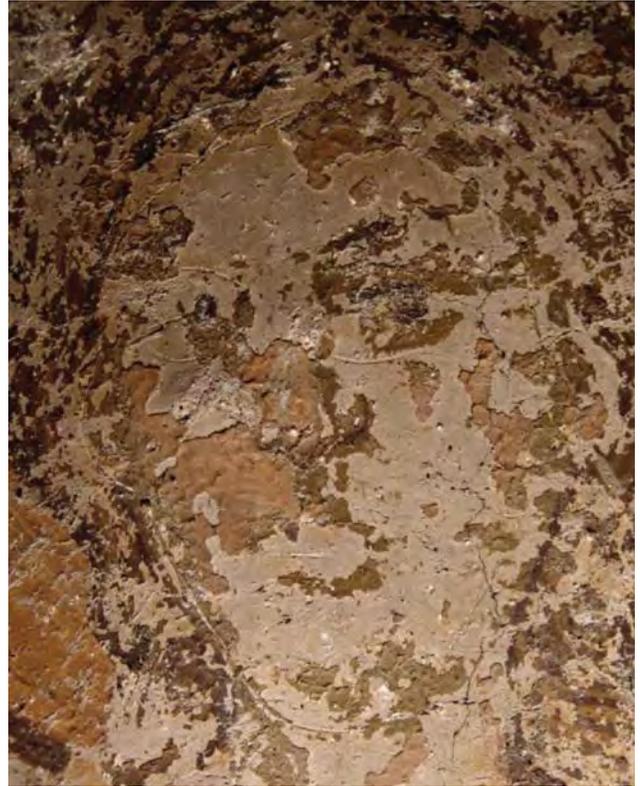
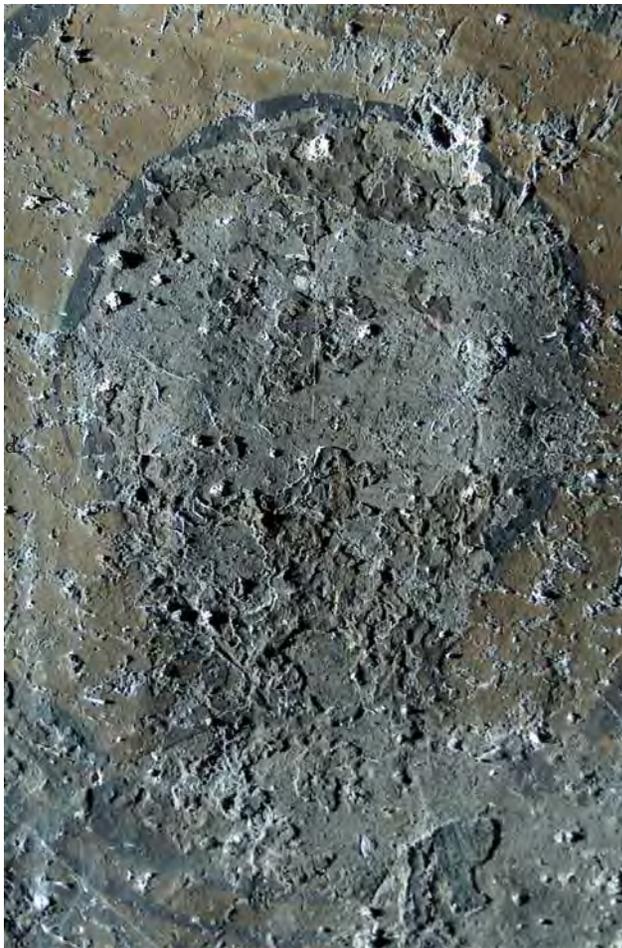
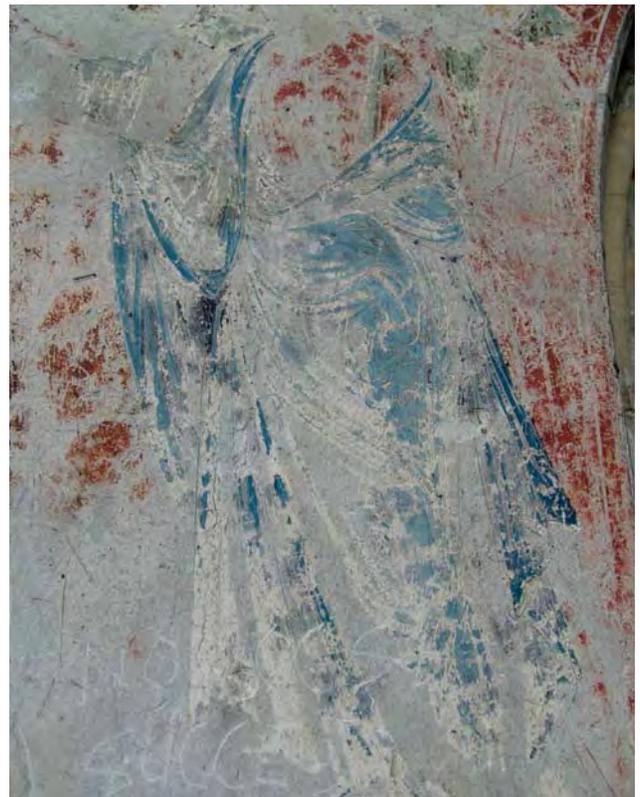
Fig. 8 a, b, c, d. Different morphologies of gaps as result of the adherence and cohesion loss of pictorial stratum in the porch of Doamnei Church (a, b, c) and in the porch of Humor Monastery, where a selective disappearance of the tone of the colour stratum can be noticed.

In the early phase of the process, when behind the colour strata there are crypto inflorescences, the dislocation of colour micro-fragments becomes visible as small bumps noticeable under grazing light. Sometimes the evolution of the phenomenon is defined due to different morphologies of the defoliation: *roof slopes, scales shapes, gondola shape* (Figs. 8 -9).

The coherence and loss of adhesion to the support of the colour strata, in the case of porches, leads to an effective loss of fragments from the pictorial strata. According to the morphology and extension of degradations, *colour layer gaps* consequently reach different shapes, from point shaped micro gaps to large gaps, and as a consequence only the painting support is visible.

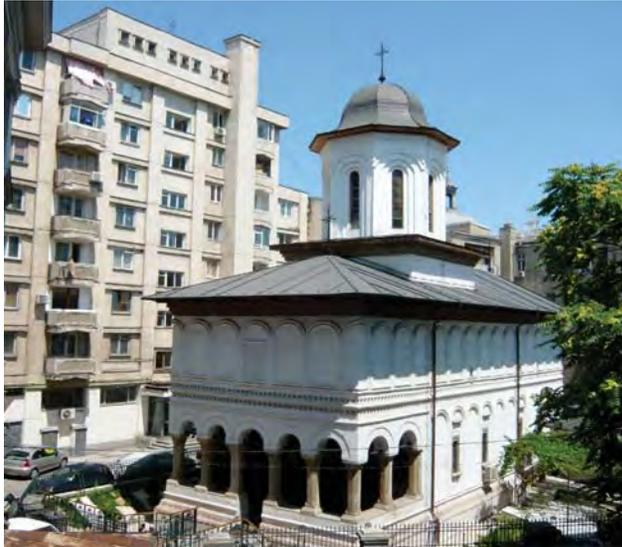
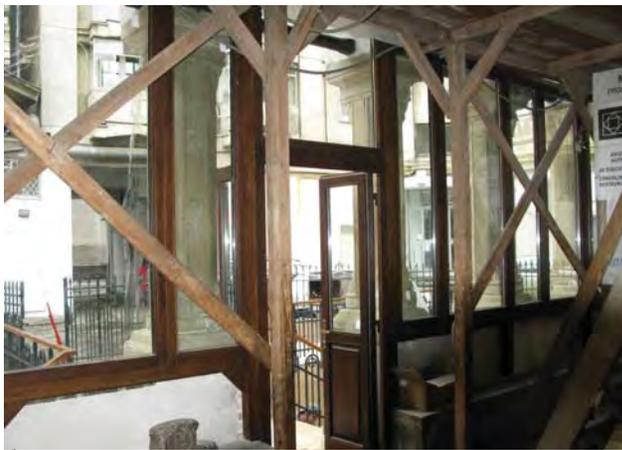
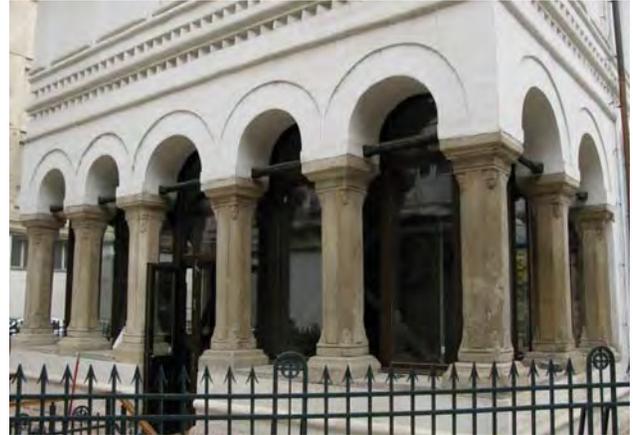
Fig. 9 a, b, c. Doamnei porch before (a) and after being closed with double glazing windows (b, c).

Among the three monuments that are subject of the present study, only at Doamnei's Church systematical determinations of temperatures and relative humidity of the air have been done up to now in order to achieve proper observations concerning the micro climate changes generated by the recent closure porch.
