THE BOLYAI NOBLE COURT. AN EARLY MODERN NOBLE RESIDENCE*

Letiția Cosnean**

Abstract: Building works on the Bolyai noble court (Buia village, county of Sibiu) was carried out in different phases over more than four centuries. Based mainly on the archival and historical sources, specialists have suggested several hypotheses regarding the patronage and the phases of constructions of the noble court. A small fragment of vividly coloured wall painting preserved on the south-eastern side of the polygonal chapel's chancel indicated the existence of the chapel in the medieval period. This had shaped the general idea that the noble court developed gradually around the existing medieval chapel. Nevertheless, little information is available regarding the architectural configuration of the noble court between the yet unknown founding date of the chapel and the middle of the 17th century.

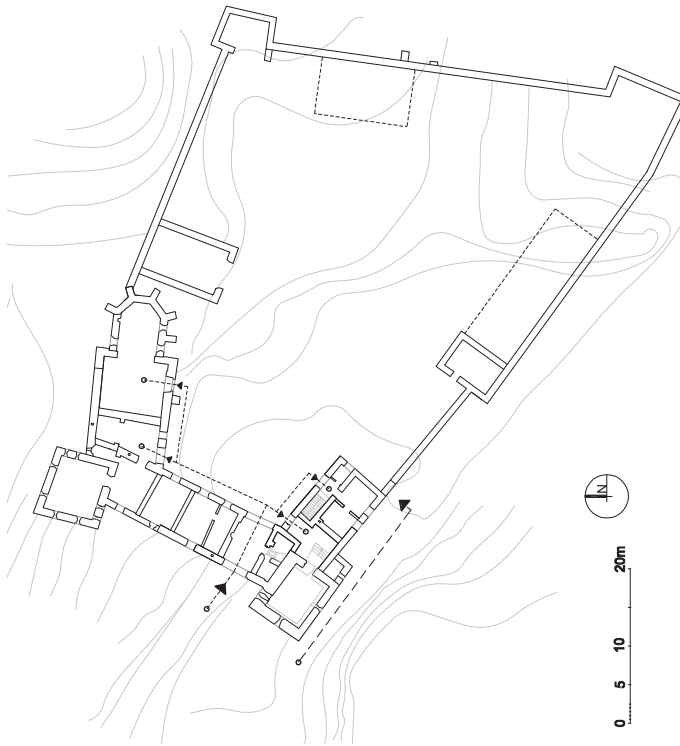
Fig. 1. Site Plan (drawing after 1928 and 1970 surveys, L. Cosnean).

Situated on a commanding position and isolated from the village by the river Calvasăr (g. *Kaltwasser*, h. *Hidegvyz*), the noble court follows an irregular rectangular ground plan shape with wings surrounding an inner courtyard (Fig. 1).³ The residential buildings occupied the west and partly the south and north wing, adjoined by a chapel on the northern side. Annexes were added on the northern, eastern and southern sides of the precinct, presumably replacing earlier wooden structures. The precinct was fortified by a continuous system of tall walls with loopholes and corner towers of *old Italian* bastion-like shape. The eastern fortification structures of irregular shapes are preserved only as ground level ruins, while the western towers had a spatial structure similar to cannon towers, combining the residential function (wide openings on the upper levels) with defence elements (loopholes at ground floor level).⁴ The main entrance gate was situated on the western wing, near the south-west tower.

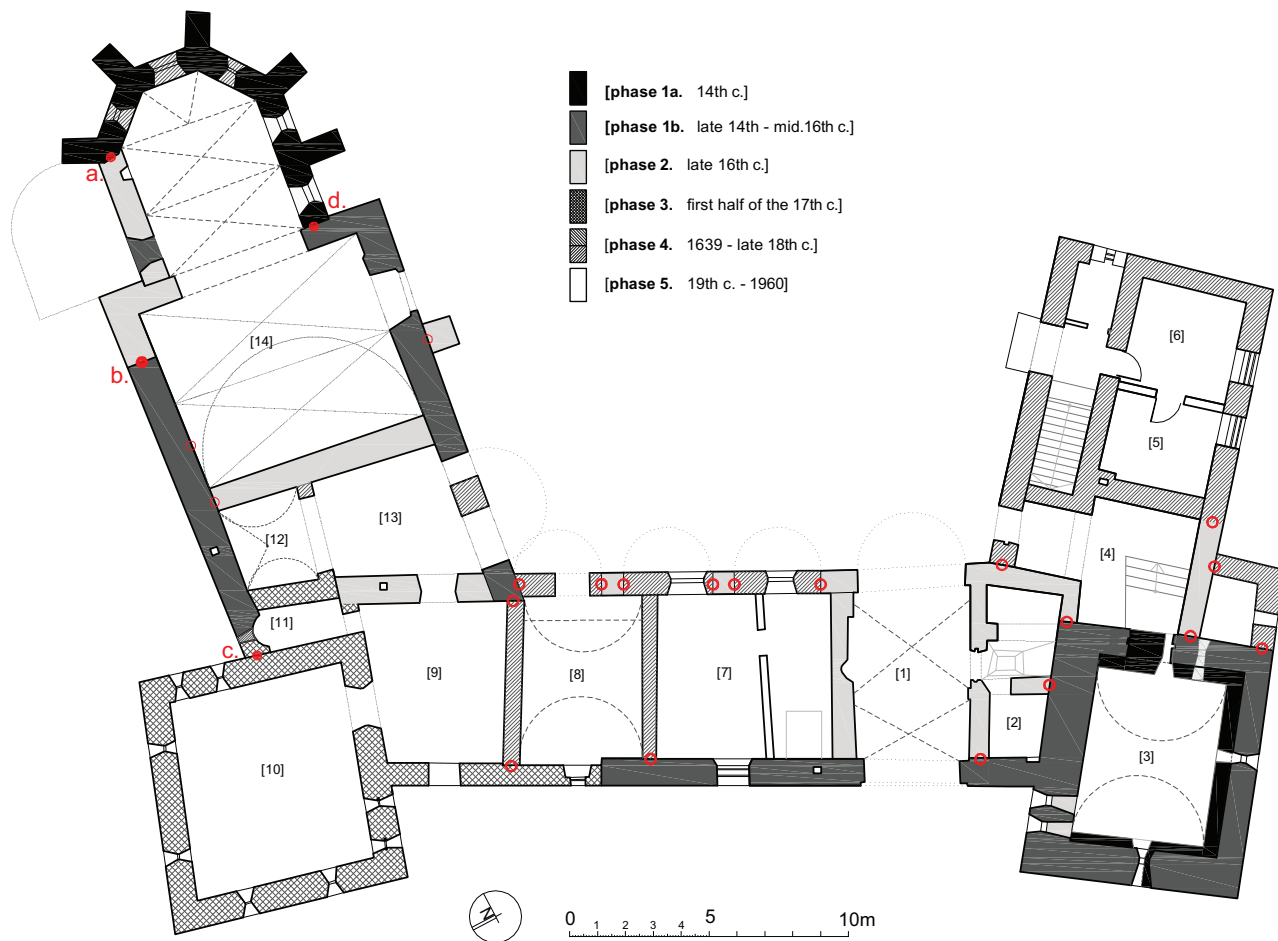
Fig. 2. Ground floor plan. Construction phases (drawing after 1928, 1967, 1970 surveys, L. Cosnean).

The walls are made of irregular river stone masonry with brick insertions, additions, or repairs. Only the annexes are built with a brick masonry structures, presumably on stone foundations. The thickness of the walls varies between 80 and 110 cm, except for the south-western tower walls which were ca. 130 cm thick at basement level. The size of the bricks varies; however we have noticed two average types: ca. 26.5 x 12.5 x 4.5 cm and ca. 23 x 15 x 5.5 cm. Most inner rooms had wooden beam floors; brick vaulted rooms were noted only at the ground floor level: the entrance gate [1], the south-western tower basement [3], the room adjoining the northern side of the south-western tower [16], and two other rooms from the northern and western wings [8, 12] (Fig. 2).

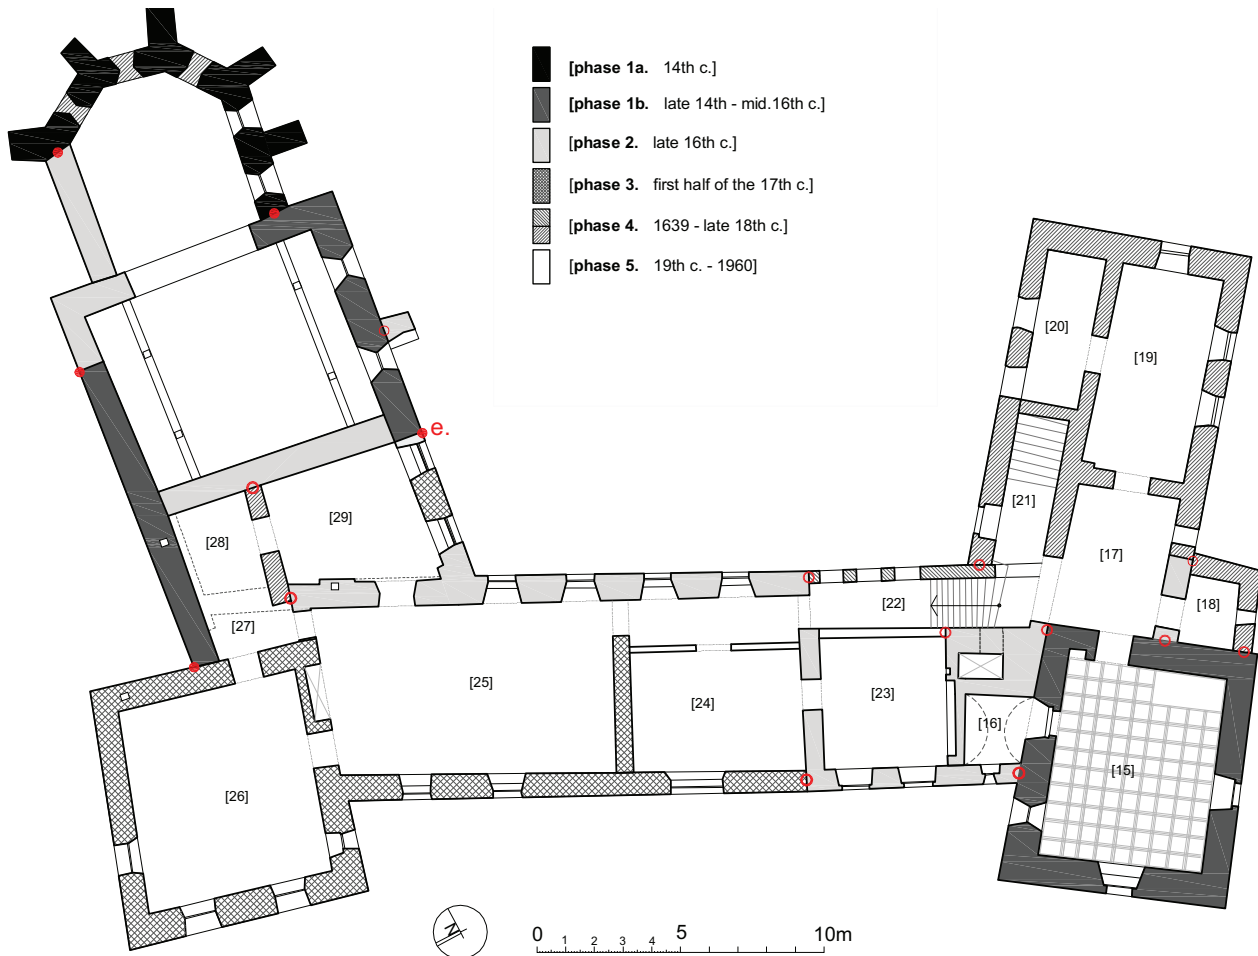
Fig. 3. First floor plan. Construction phases (drawing after 1928, 1967, 1970 surveys, L. Cosnean).

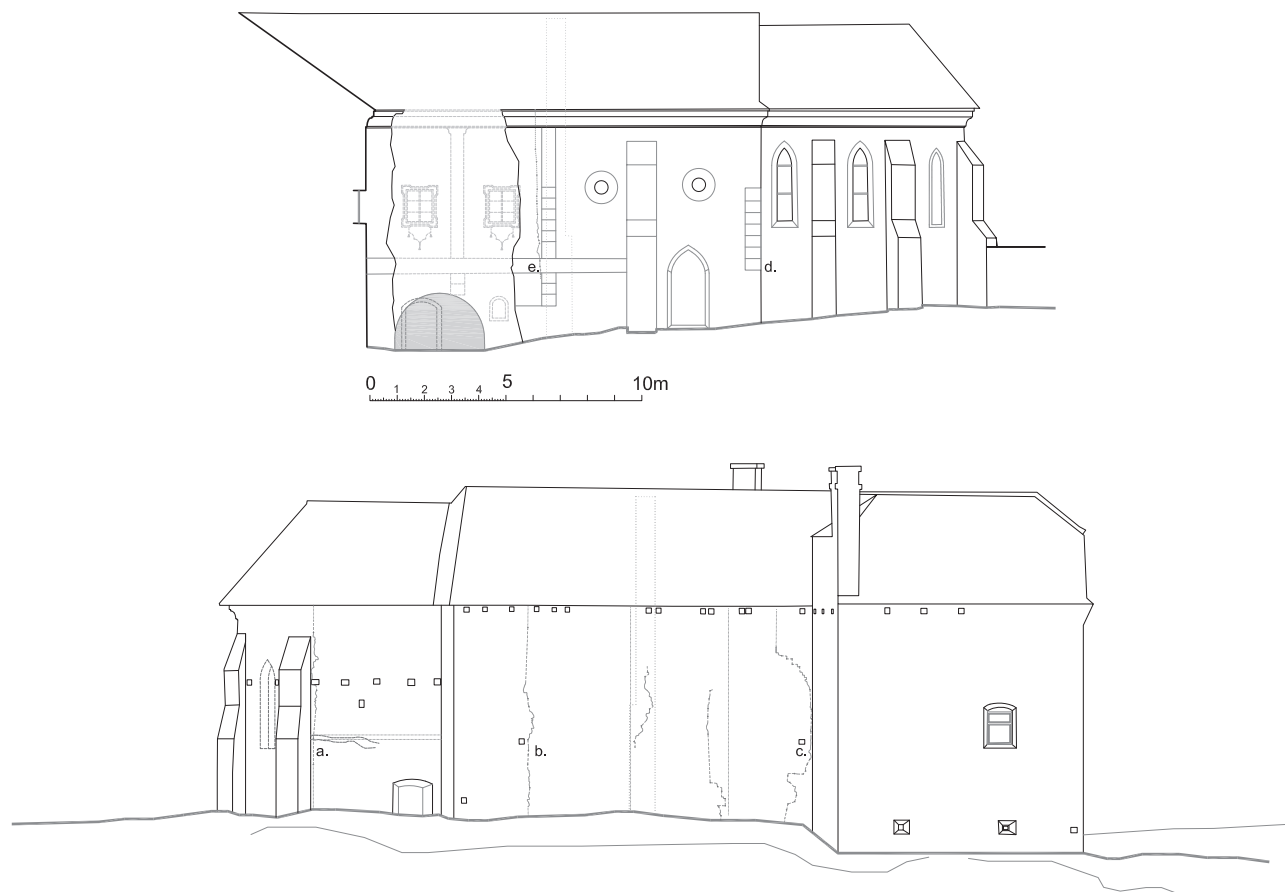
Fig. 4. Chapel – southern and northern facades. Visible remains of the sacristy's vault springer, and lines of adjacent, unconnected masonry (drawing after 1970 survey, L. Cosnean).

the whole height of the walls on the northern side of the chapel (Fig.4. a, b, c). The *a-b* section of the wall might represent a repair of the chapel, probably related to the addition of the sacristy (*phase 2*), whereas the *c* line related to a perpendicular wall³⁸ might represent the north-western corner of an earlier church (*phase 1*). However, the connection of the chapel with the court's west wing in the form preserved until today represents a later phase of construction, probably related to the building of the north-western tower (*phase 3*).

On the surface of the northern precinct wall one may notice three types of holes in the masonry. Starting with the north-western tower until the walls of the chapel's choir, a continuous row of putlog holes (ca. 19) was visible.³⁹ They might have been intended to take the supporting wooden beams of a hoarding built along the wall. Another row of putlog holes is still visible on the northern side of the chapel's choir until the second buttress, but situated lower than the previous ones. Their function might have served as well for supporting a system of wooden fortification corresponding to the choir, similar to the many examples of Saxon fortified churches from southern Transylvania.⁴⁰ Other type of holes can be seen spread over the wall's surface, without a special alignment (ca. 4); they might have been used for supporting some temporary scaffolding (Fig. 4).

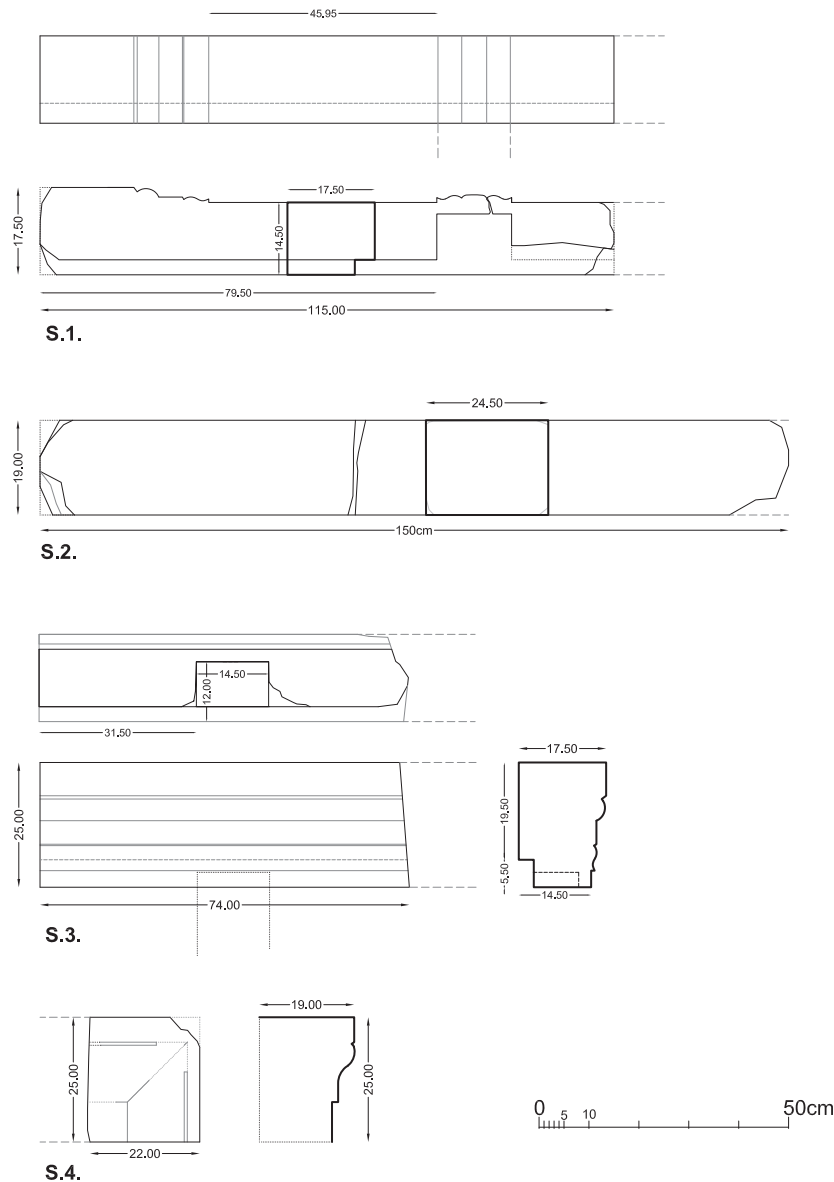
Fig. 5. Limestone frames' fragments. *Spolia* incorporated in the north-western tower (S.1-S.4) (L. Cosnean).

His role in the patronage of Buia castle is undeniable. He received the possession after more than half of century of repeated donations and confiscations. The church repair from the north-eastern corner of the nave (Figs. 2, 4) might be dated in this period. Moreover, a fragment of carved limestone door frame (**S.7.**), still visible in a reused position in 1928,⁸⁴ bears an inscription with his name (Fig. 6). Comparing it with the *in situ* door frame, it is larger and has more refined mouldings, indicating a possible provenance from the castle's *hall* [rooms 24 and 25] (Fig. 3). A group of four limestone *spolia* (**S.1-4.**), with mouldings of similar

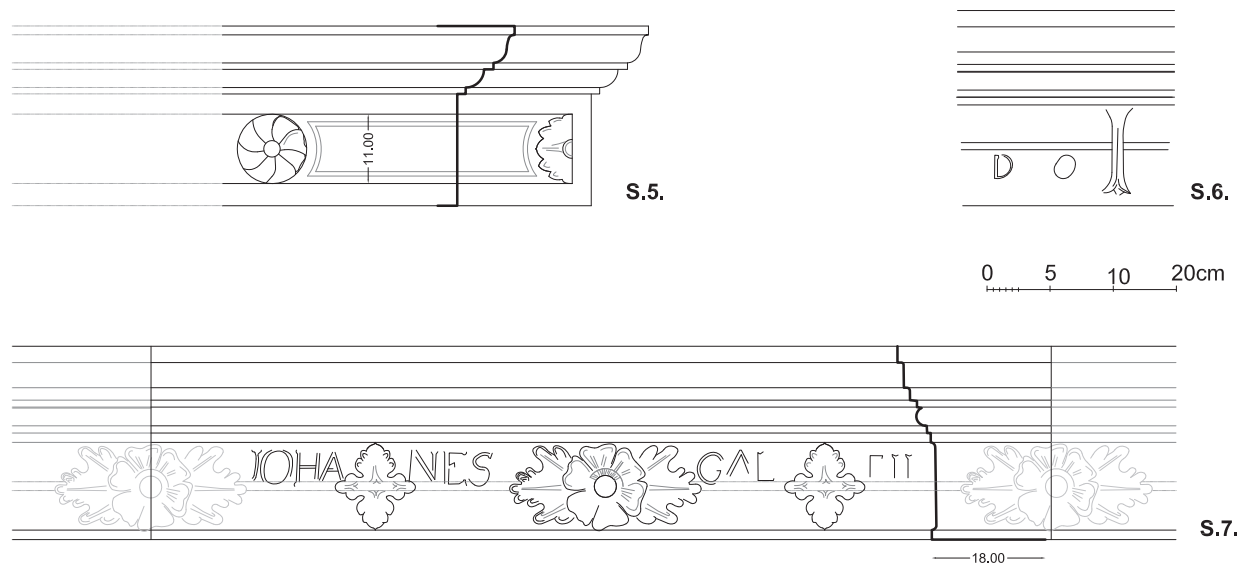
Fig. 6. Fragments of limestone frames of Renaissance type (catalogue nos. **S.5-7.**) (drawings after Debreczeni 1928, 253, L. Cosnean). Analogies: 1. Decorative motif of a door frame (Criș, Bethlen castle, 16th c.); 2. Rosette pattern on the Boghner chimney (Cluj-Napoca, 16th c.).

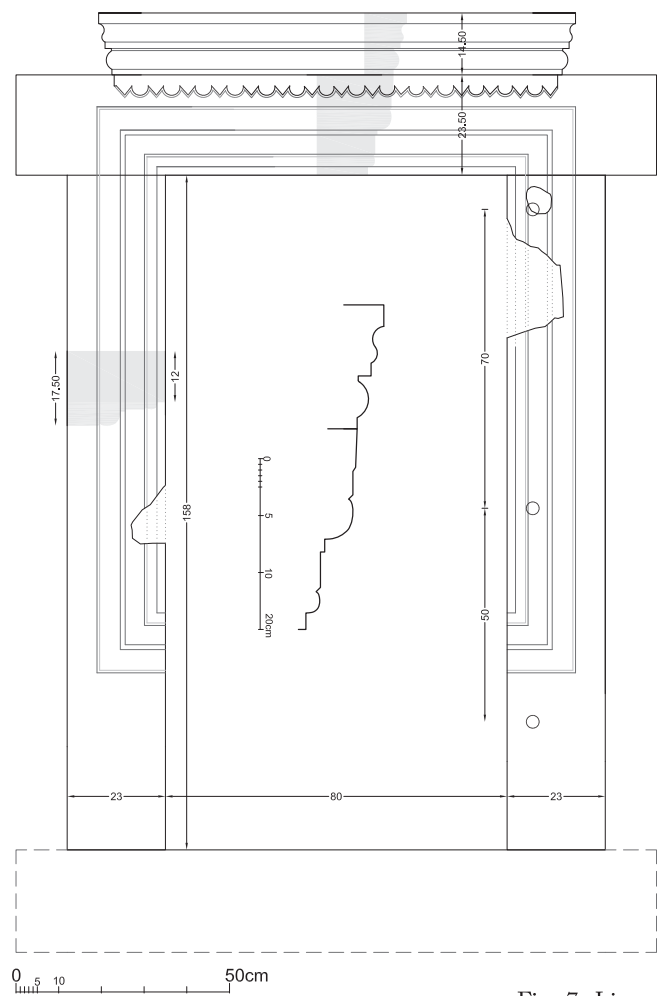
Fig. 7. Limestone door frame preserved *in situ* (catalogue no. **A.1.**) (drawing after original, L. Cosnean).

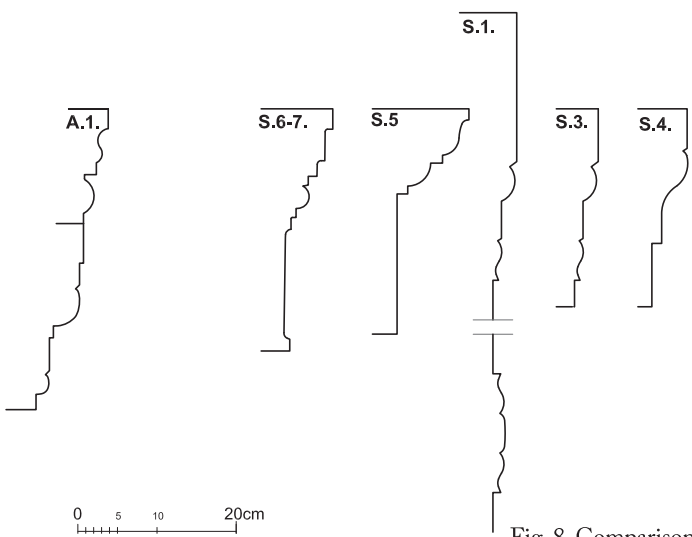
Fig. 8. Comparison of limestone blocks' mouldings.

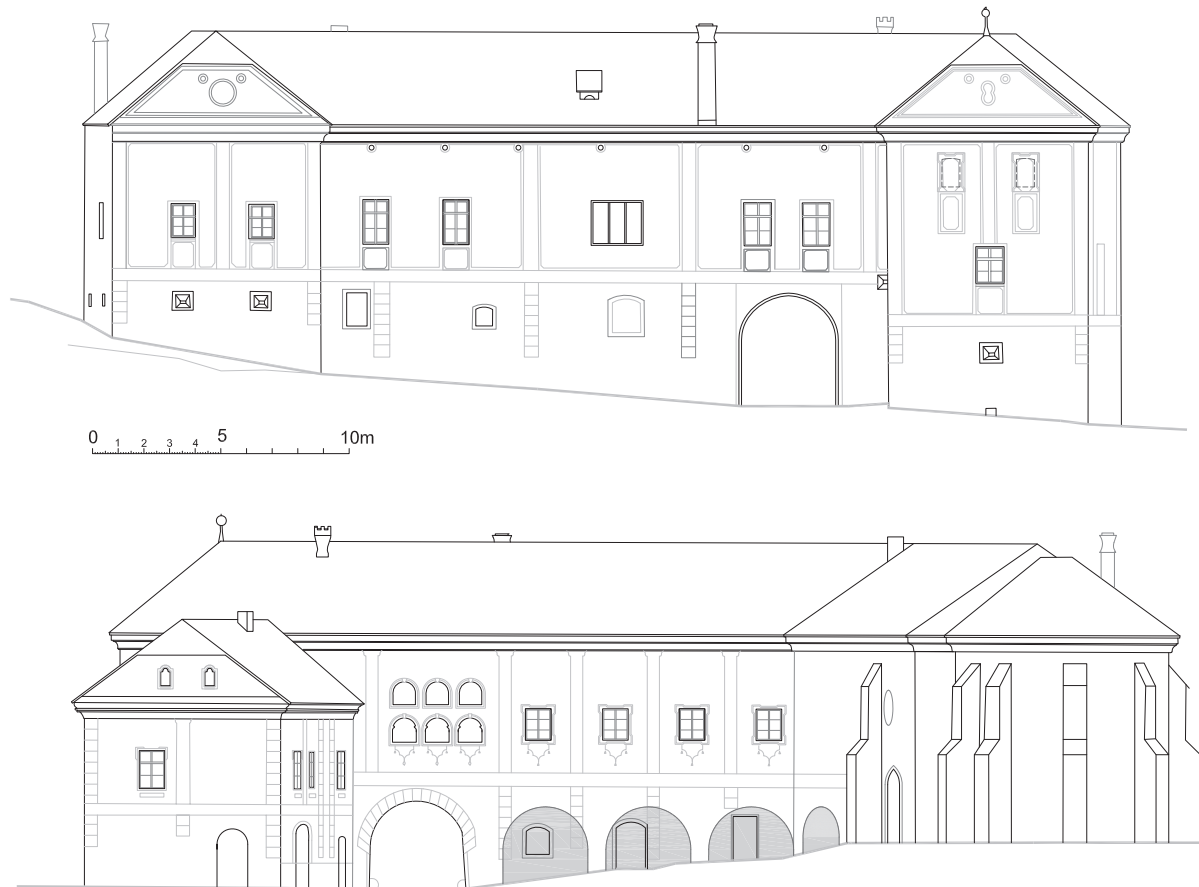
Fig. 9. Court west wing – western and eastern facades (drawing after 1970 survey, L. Cosnean).

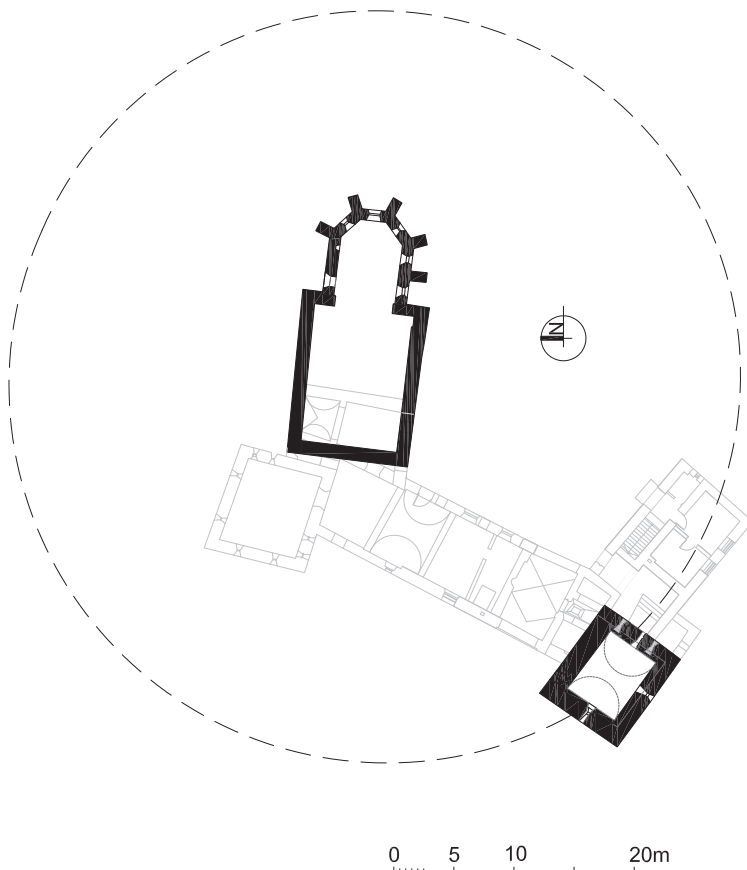
Fig. 10. Site plan - chapel and residential tower. Hypothesis regarding the first building phase (L. Cosnean).

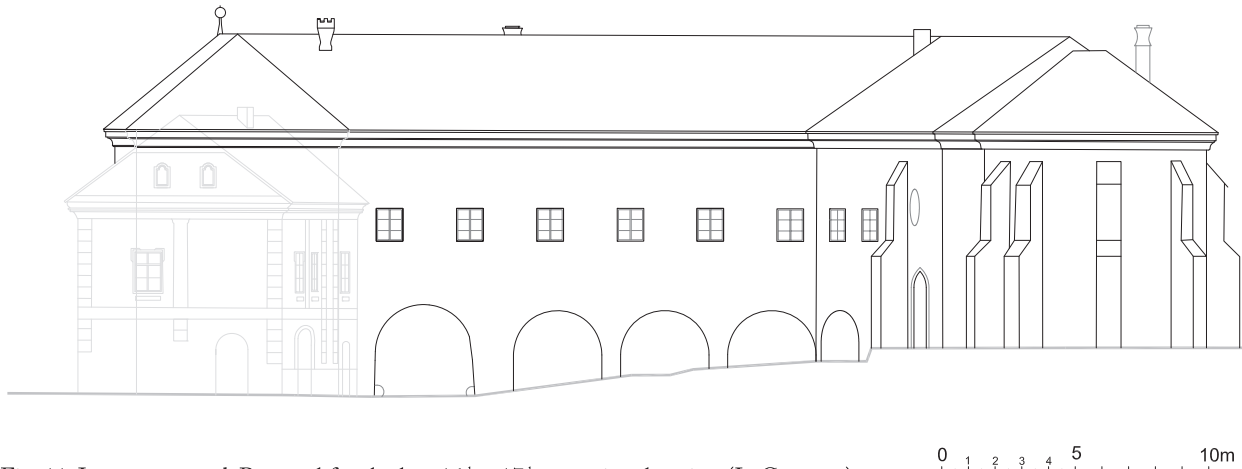
Fig. 11. Inner courtyard. Proposal for the late 16th – 17th centuries elevation (L. Cosnean).

proportions and formal composition testifies to the large framed openings which the castle accommodated. Therefore, I assume that the building of the western wing was already completed during this phase. In the same time, the western wing's arcaded ground floor reminds of the composition of the interior courtyard of the princely palace of Alba Iulia, where Gálffi might have found both the source of inspiration for his residence, and maybe also advice (i.e. court architects, military engineering, craftsmen).⁸⁵ A proposal for the formal reconstruction of this facade eliminated the overlapped arcaded openings from the first floor windows and continued the rhythm of the second level windows with two more openings (Fig. 11).

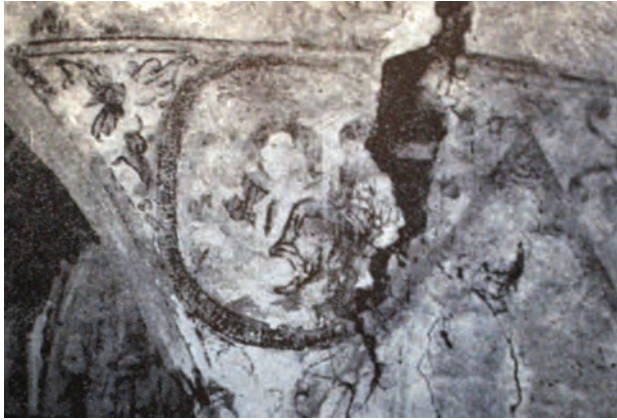
Fig. 12. Painted decoration on the chancel arch: profile of an angle-faced girl with flowers (after Bielz 1964, p. 233, Fig. 7).

flowers in her hands, encircled by a medallion with a Latin inscription (Fig. 12);⁸⁹ inside the altar, a bright green undulated stalk with leaves and flowers decorated the vault ribs' sides, while the front side is enriched by green round pearls alternating with ovals, and connected through a black thread (Fig. 13). On the outer side of the chapel's south-eastern corner, one can still see fragments of a painted decoration suggesting a rustication pattern (Fig. 14).⁹⁰

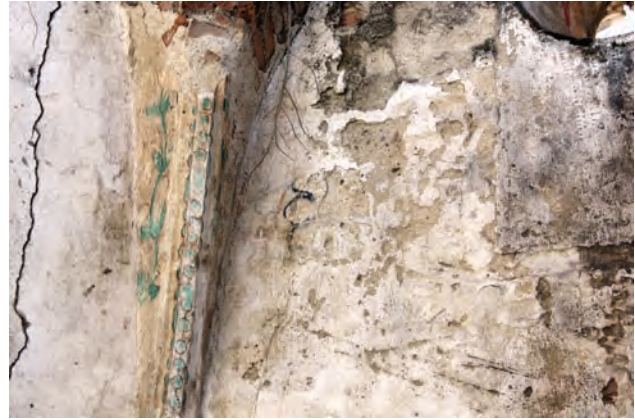
Fig. 13. Painted decoration on the rib vaults of the chapel choir (photo 2012: L. Cosnean).

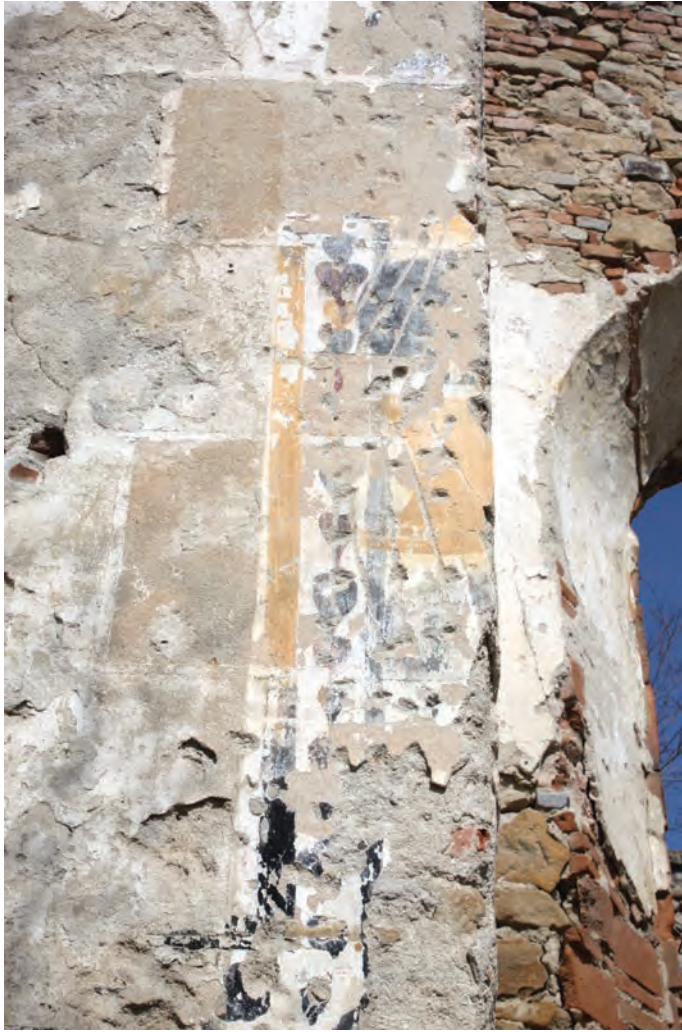
Fig. 14. Chapel's exterior decoration. Painted *rustication* of the south-eastern corner (photo 2012: L. Cosnean).

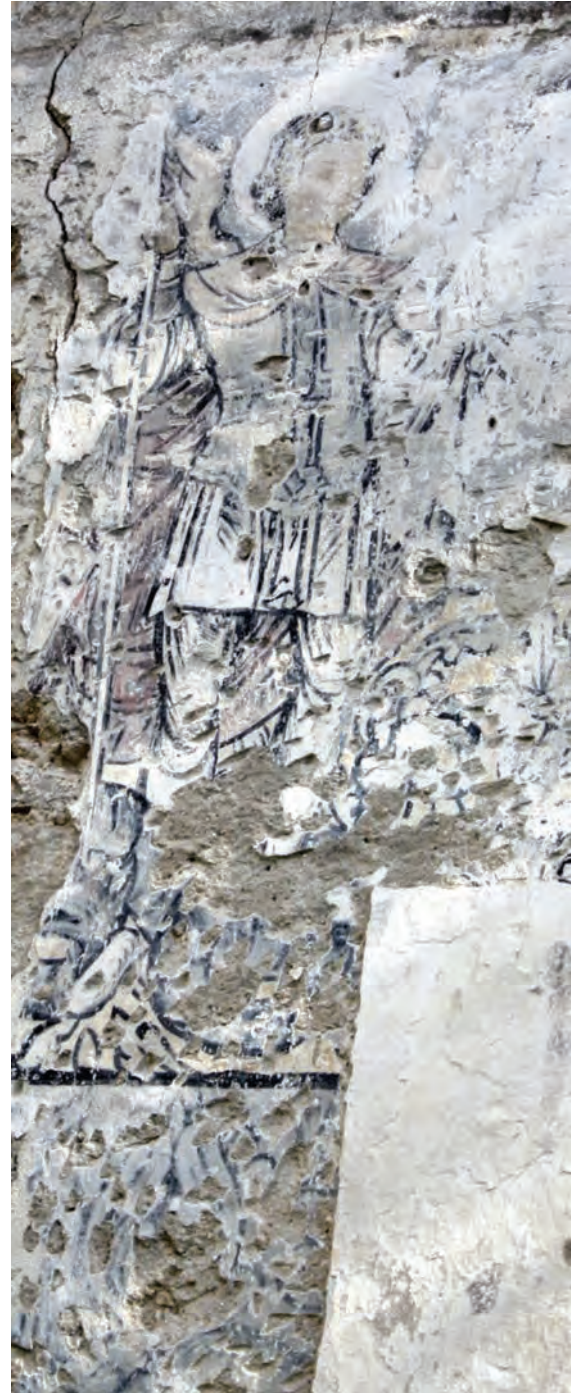
Fig. 15. Archangel St. Michael, outer side of the chapel's west wall (photo 2012: L. Cosnean).

Even less decoration was preserved inside the residential rooms. Nevertheless, traces of a painted representation of Archangel Michael, near three cartouches with inscriptions and a foliage decoration were revealed during a campaign of inventorying the mural paintings of medieval Protestant churches.⁹¹ The representation covered the upper half of the eastern wall from the first floor room adjoining the chapel [no. 29], but few traces are preserved on the southern wall as well. The Archangel is depicted as an angelic warrior with a sword in his right hand, probably standing over a dragon or a serpent (Fig. 15).⁹² St. Michael was the patron of a large number of funerary chapels from Transylvania since medieval times;⁹³ his hypostasis as an angelic warrior slaying a serpent has been used for portraying the victory of good over evil, and in the same time for representing a model of the spiritual warrior's virtues. Therefore the inscriptions represented on his left side could have been quotations with moral content. Below the cartouches a wide border, which seems decorated with a floral and foliage Evolute-spiral pattern, delimited the upper part of the wall. The lower part is much deteriorated; only fragments of grey (light blue) and red color could be distinguished. The function of the space is yet unclear, but the Bolyai family chronicle mentions that during the "Pernészi time" a priest's residence was located in the north wing, near the chapel, with a direct access to the chapel sacristy through stairs and a corridor.⁹⁴

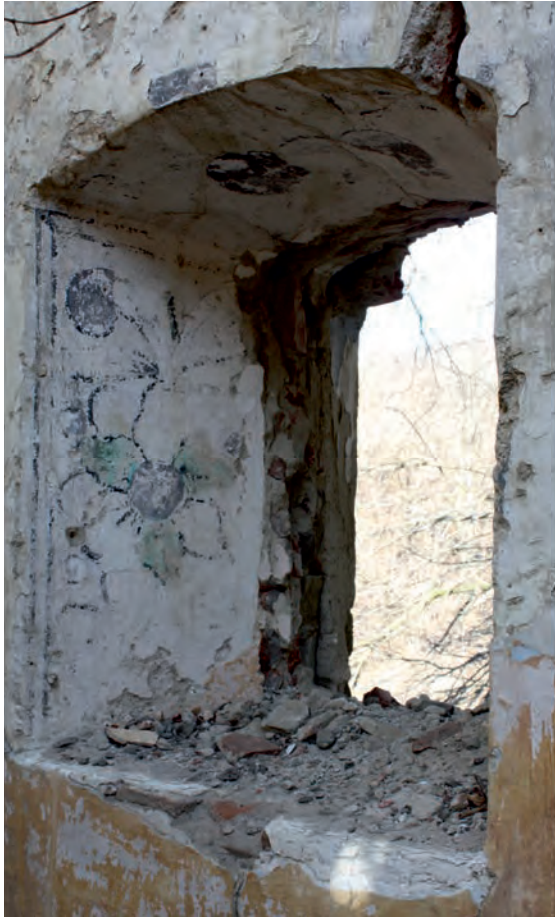
Fig. 16. Mural painted decoration. Window splays on the first floor of the south-western tower (photo 2012: L. Cosnean).

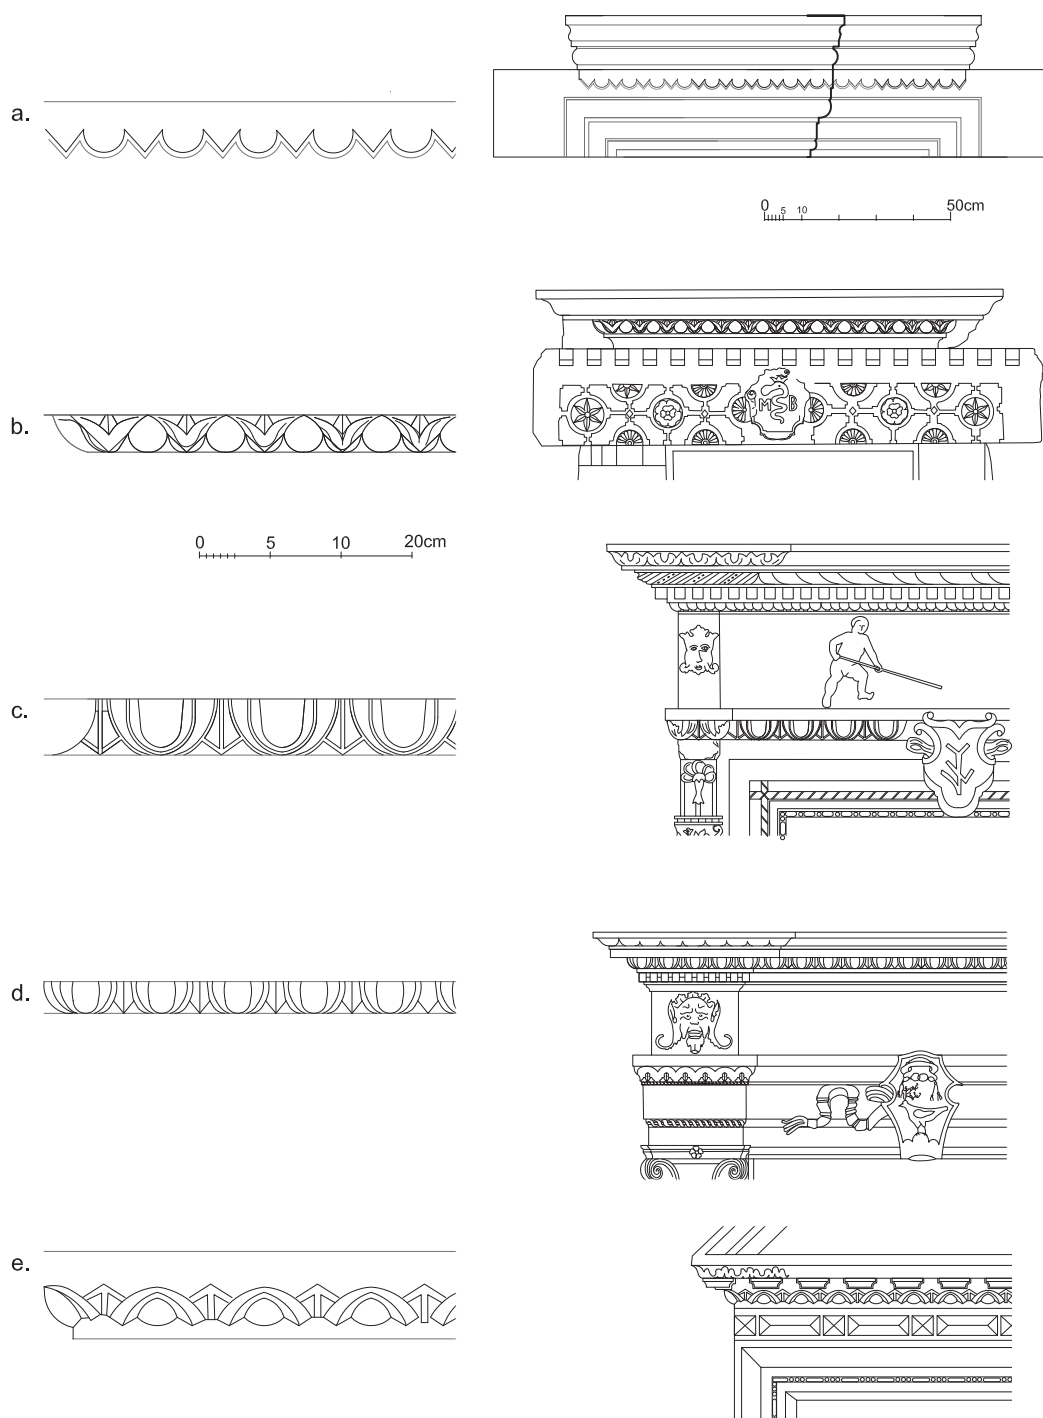
Fig. 17. Comparison of egg-and-darts decorative pattern carved in stone: a. Limestone door frame – Bolyai castle, Buia (L. Cosnean); b. Limestone door frame, 1646 – Bethlen castle, Criș (after Sebestyén 1963, p. 65, Fig. 33); c. Limestone door frame, 1552 – Teutsch house, Sibiu (after Sebestyén 1963, p. 226, Pl. 21); d. Limestone door frame, 1541, Wolphard-Kakas house, Cluj-Napoca (after Sebestyén 1963, p. 148, Pl. 12); e. Limestone window frame, 1646 – Bethlen castle, Criș (after Sebestyén 1963, p. 186, Fig. 31).

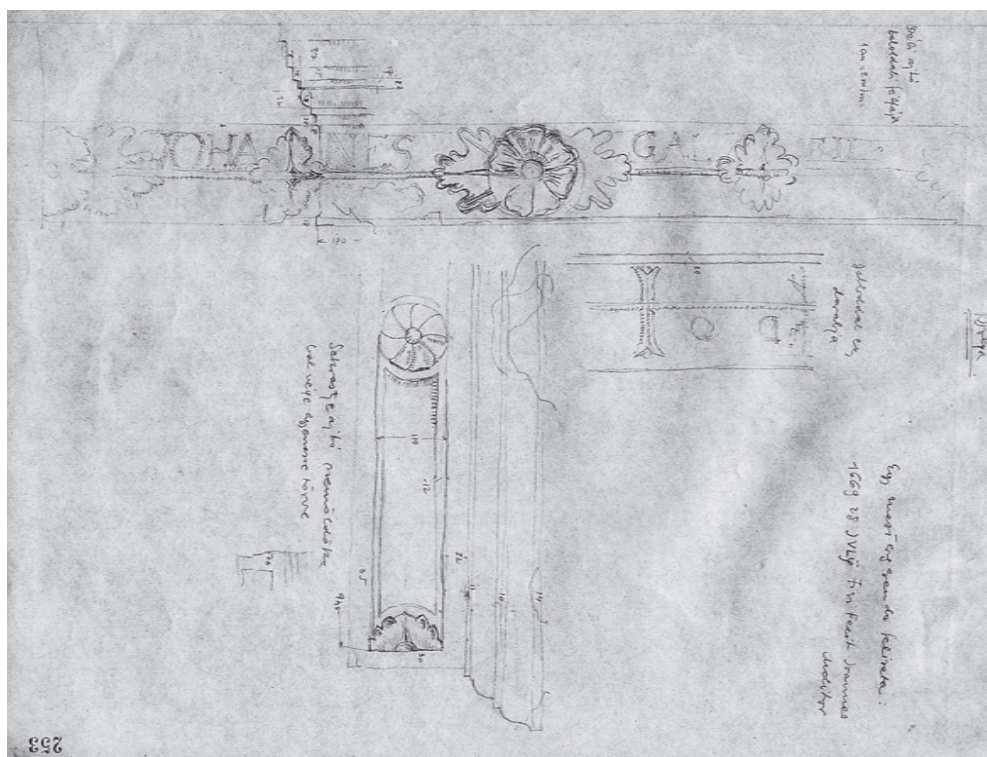
Fig. 19. Limestone fragments. Original measurements drawing by Debreczeni László, 1928 (KÖH plans archive, Budapest).

¹¹³ Fragments **S.5.-S.7.** are no longer preserved on site; they were either transported to an unknown location or lost. Their survey was realized after a hand drawn survey by Debreczeni Laszlo from 1928, found in the KÖH plans archive. The information regarding the decoration and the dimensions are not comprehensive; small details have been added by the author on the base of geometrical construction.

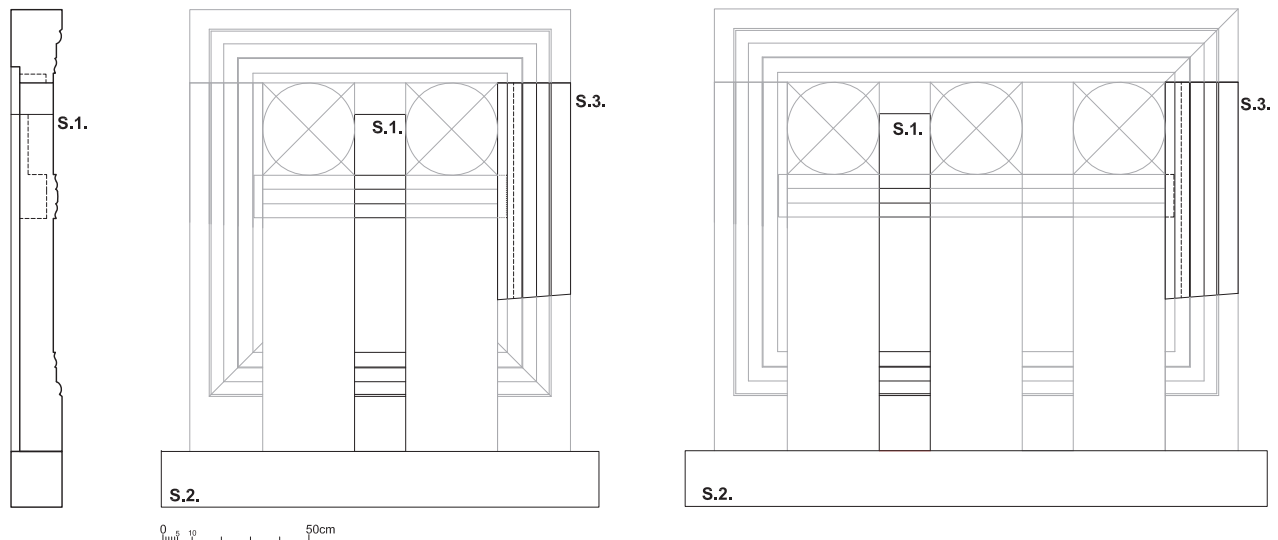
Fig. 20. Hypothetical reconstructions of window frames (with blocks **S.1.**, **S.2.**, and **S.3.**) (L. Cosnean).

with the middle profile, indicating a connection with an adjacent block, and a recess develops on the whole length of the block. Based on these observations, I have suggested two types of window frames comprising this block: a two or a three-light mullion window frame (Fig. 20).

Simple block, with fine finished dressed faces. The surfaces are highly eroded and the fragment is broken at one end, therefore one does not know if the original block exceeded 150 cm or not. In the reconstruction proposal, the fragment is envisaged as a simple sill (Fig. 20).

Block with moulding broken at one end. It has an identical moulding with the edge moulding of **S.1.** block: ca. 6.70 cm framing band, an *ovolo* profile, and a *cyma reversa* separated by a *fascia*. One of the side faces of the block presents a rectangular shape mounting groove similar to that on S1 block, with similar dimensions: 12 x 14.50 cm, indicating the connection place with an adjoining block, possibly even **S.1.** The proposed reconstruction using these two blocks (**S.1.** and **S.3.**) suggests that the **S.3.** block might represent the interior mullion of a two or three-light transom window frame (Fig. 20). A recess continues in a similar way on the entire length of the side face.

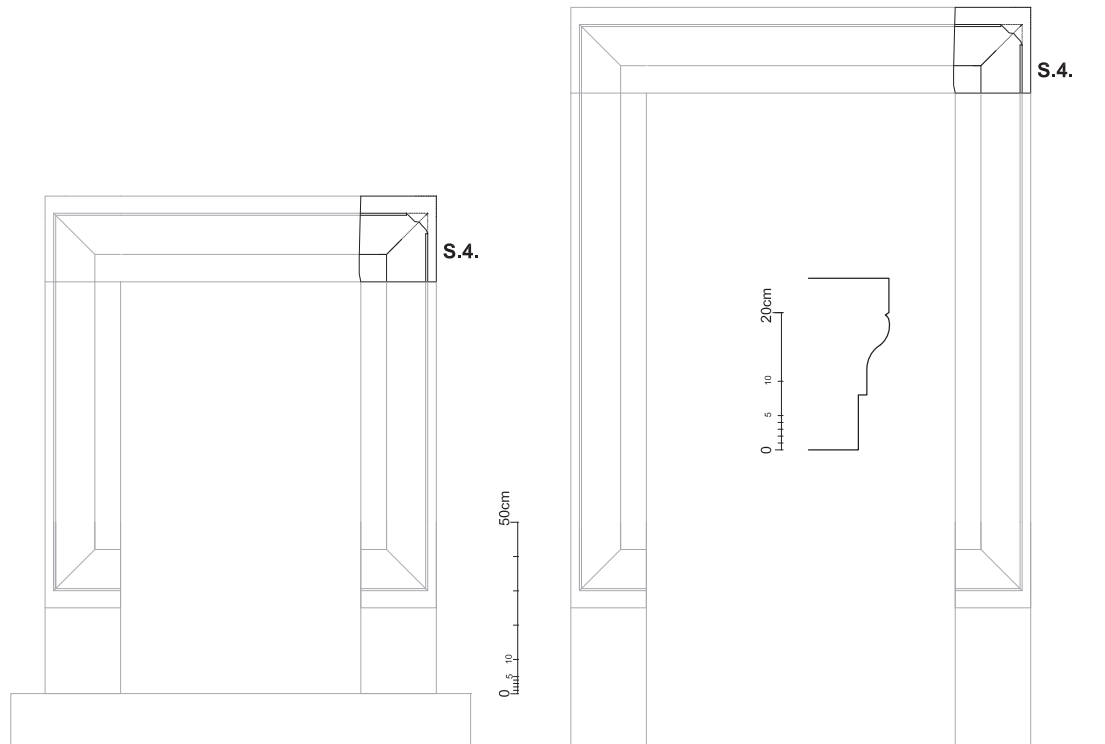
Fig. 21. *Hypothetical reconstructions of door and window frames (with block S.4.) (L. Cosnean).*

A corner block with fine and elongated profiles - a *cyma reversa* framed on the outward part by an unequal border (5 cm, respectively 2.50 cm wide) and a flat 7 cm-wide fascia in the lower part. The moulding

structure and composition is frequently used for window or door frames in 16th-century Transylvania (e.g. Lázoi chapel, Alba Iulia (1521),¹⁰⁸ Bocskai castle, Aghireș (late 16th century),¹⁰⁹ Wolphard Kakas house, Cluj (1534),¹¹⁰ and Apor house, Alba Iulia).¹¹¹
