MEMBRA DISIECTA. ROMAN LITHIC FRAGMENTS IN HAȚEG (Part II)¹

MONICA MĂRGINEANU CÂRSTOIU, VIRGIL APOSTOL, ȘTEFAN BÂLICI

Ostrov (Municipality of Râu de Mori). The enclosure of the Church of the Descent of the Holy Spirit

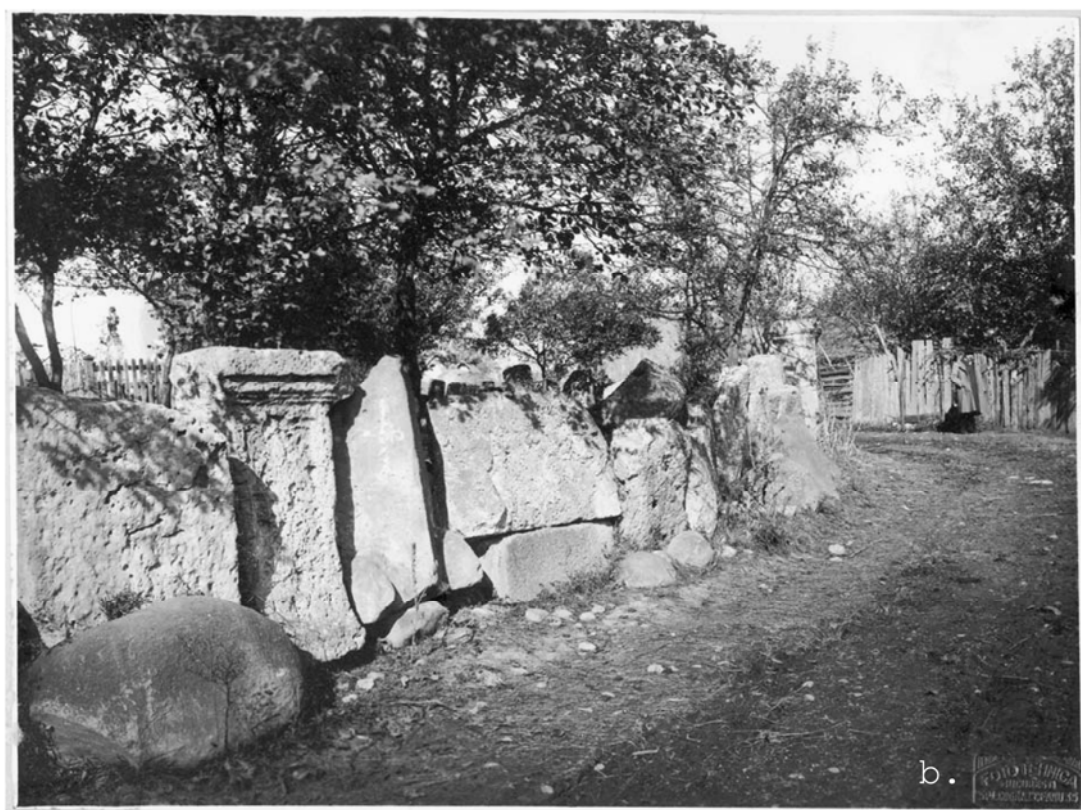
Fig. 1. *a* The Church in Ostrov; *b*: detail with the enclosure - block no. inv. 27 (photograph taken in 1933, The Archives of The National Institute of Historic Monuments, File DMI); *c*: The plan of the church and of the enclosure cf. A. A. Rusu, *Cițitori și biserici din Țara Hațegului până la 1700*, Satu Mare, 1997, fig. 32, 34, p. 238, 240).

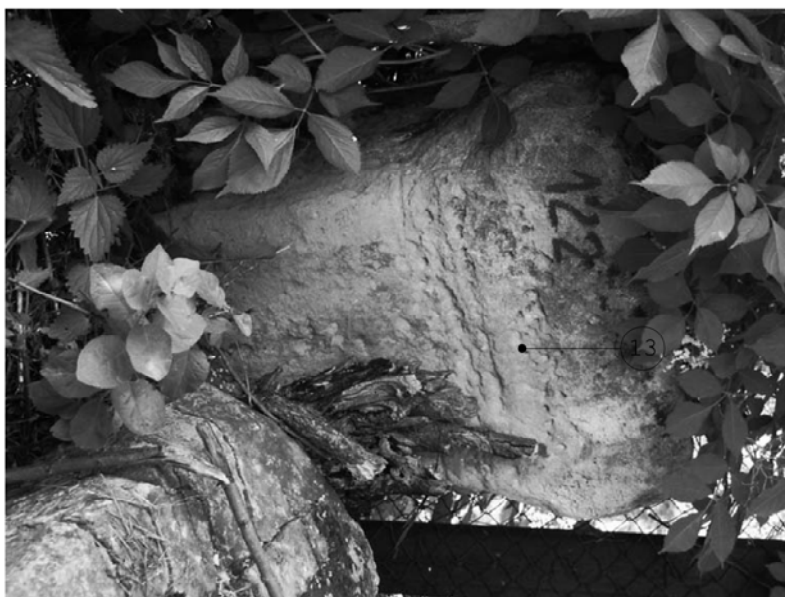
Fig. 10. Funerary stele **II.2.** (inv. no. 13 a, b, c).

The lower part buried in the ground. Advanced state of decay. The panel, rectangular, is divided in three sections, separated by horizontal listels(?), highly eroded. The median section is taken by a medallion, encircled by a crown (its outer radius of 29.7cm), doubled outwards by a talon moulding. The crown encloses a concave disk, with the bust of the dedicant carved inside it (*imago clipeata*). The details of the crown are lost, but two thin ribbons and a few very ample, sharp-tipped leaves can be perceived. The bust is carved in underplayed relief. The trace of a toga (?), draped down the left shoulder is preserved. The high section unfolding above the medallion bears the traces of an ornament (probably with garlands) of unclear decorative content.

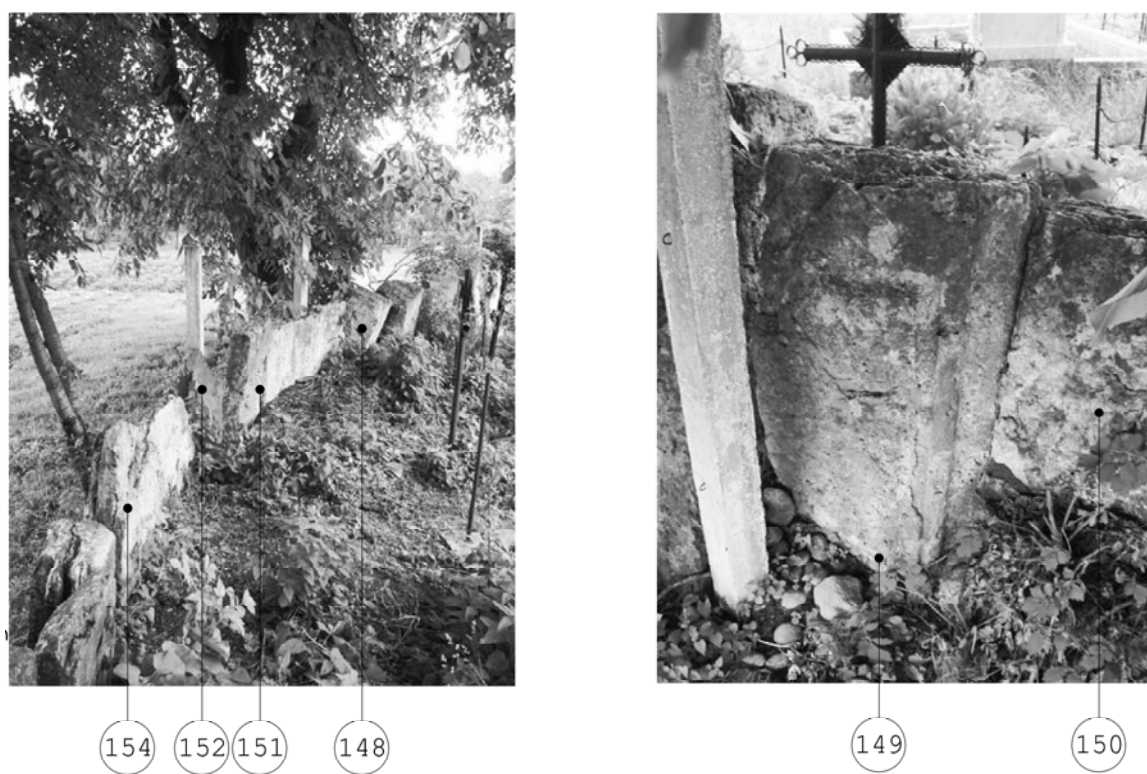
Fig. 15. Corner block **III.2.** (inv. no. 152).

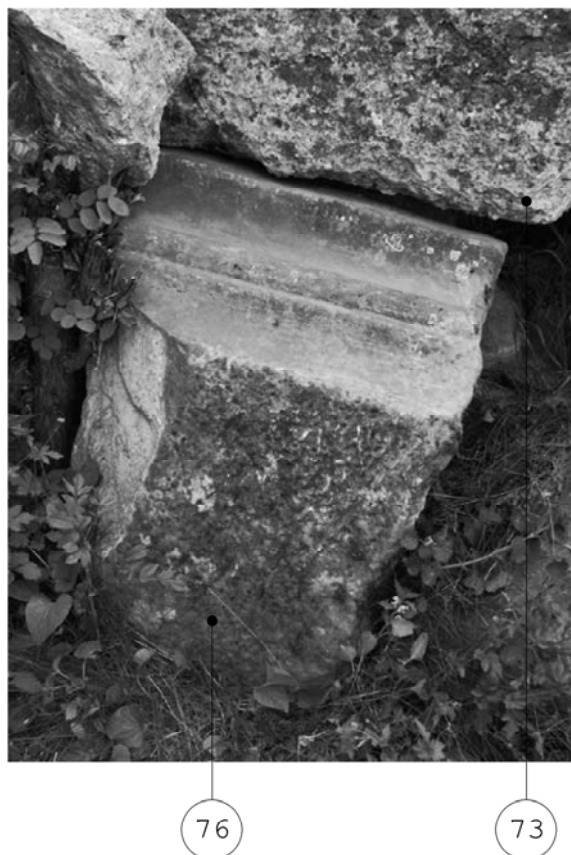
Fig. 17. Horizontal cornice **IV.5.** (inv.no.76).

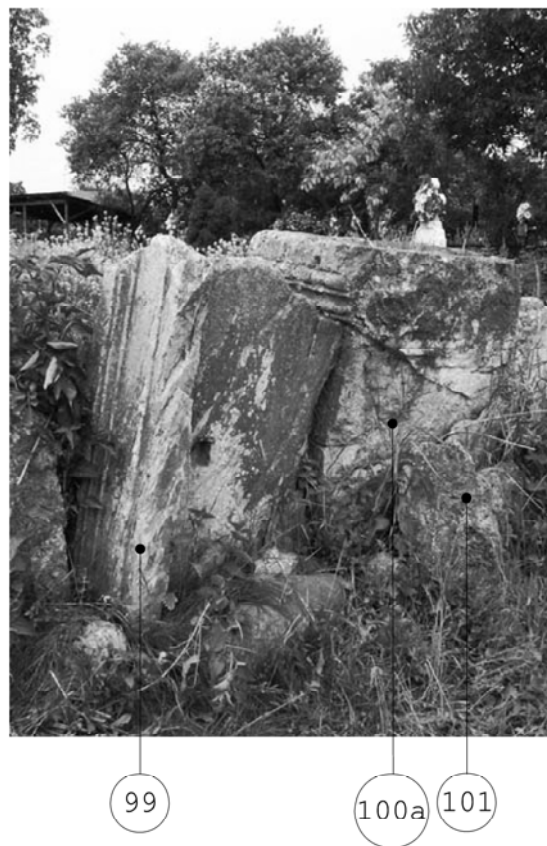
Fig. 18. Block with architraved decoration **V.1.** (inv. no. 99).

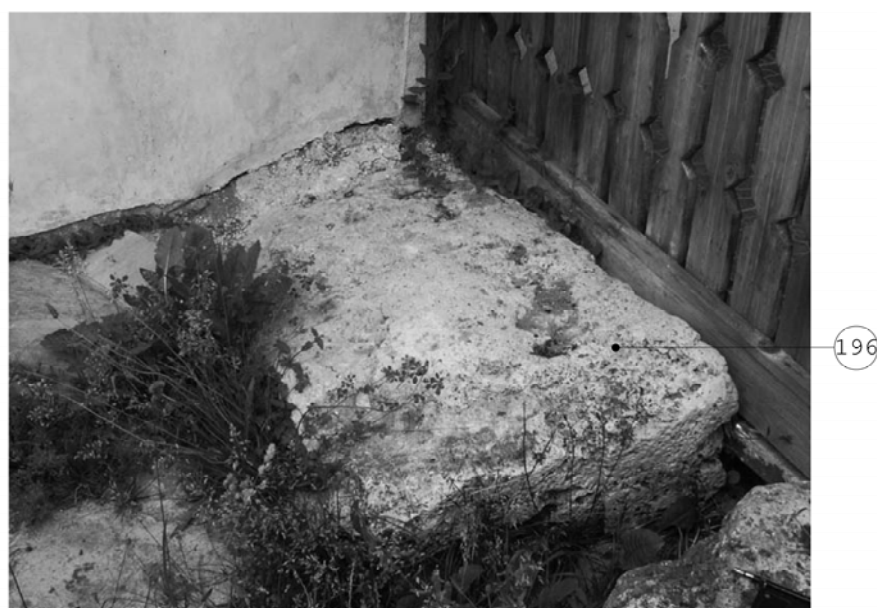
Fig. 19. Architrave **V.2.** (inv. no. 196).

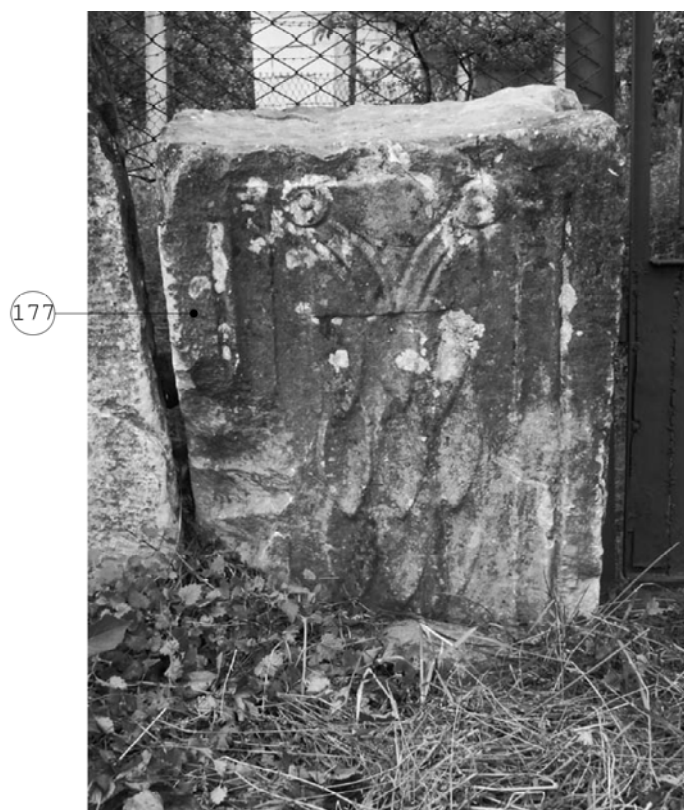
Fig. 20. Block with laurel leaves **VI.2.** (inv. no. 177).

Block with “L” section and clamp groove on the bedding surface. The rear face and the side ones bear traces of rough finish. It is largely buried. If these were original features and not the result of secondary use, the block should be considered in a reversed position as to its actual one, with the garland horizontal. In this case the decorated façade represents a decorative frieze of a (funerary) monument. In the less probable hypothesis of a secondary use as the source of both the mounting groove and the rough aspect of the side faces, the block might be considered, standing vertically, as the decorative pilaster of the funerary monument (see Pl. XXIII)

Following another conjecture, block **VI.2.** is set upright, making decorative pilasters. (Pl. XXIIIb) In this case one must either accept that the clamp groove is resulted out of secondary use, or consider it as belonging to the original monument, but used atypically. Such an utilisation can be accepted if the block necessitated repairs, maybe even during the construction of the monument, the clamp tying, vertically, two fissured or even broken fragments.

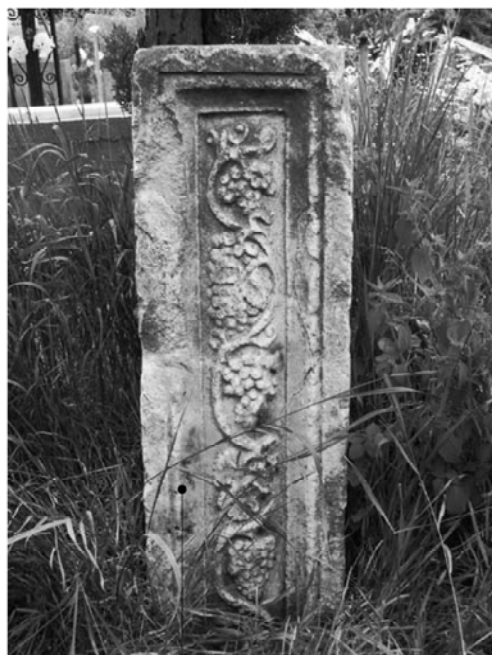
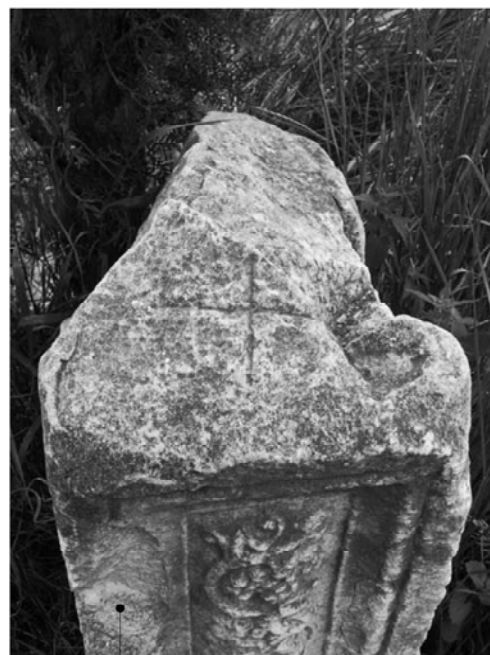
Fig. 21. Decorated block **VI.3.** (inv. no. 194).

The central panel, surrounded by an overturned talon moulding, is decorated with a *rinseau* of grapevines and bunches of grapes alternately set. The rear face is partly broken. On the present upper surface – partly destroyed – one can see the traces of a finish reminiscent of *anathyrosis*; inside the surface there is a cross-shaped sign (carved when the block was reused as a gravestone).

The bedding surface bears, in its rear, deteriorated part, the vague traces of a dowel groove. It belongs probably to one of the decorative pilasters of a monumental funerary altar (Pl. XXIIc) or of a pilaster monument.⁵⁰

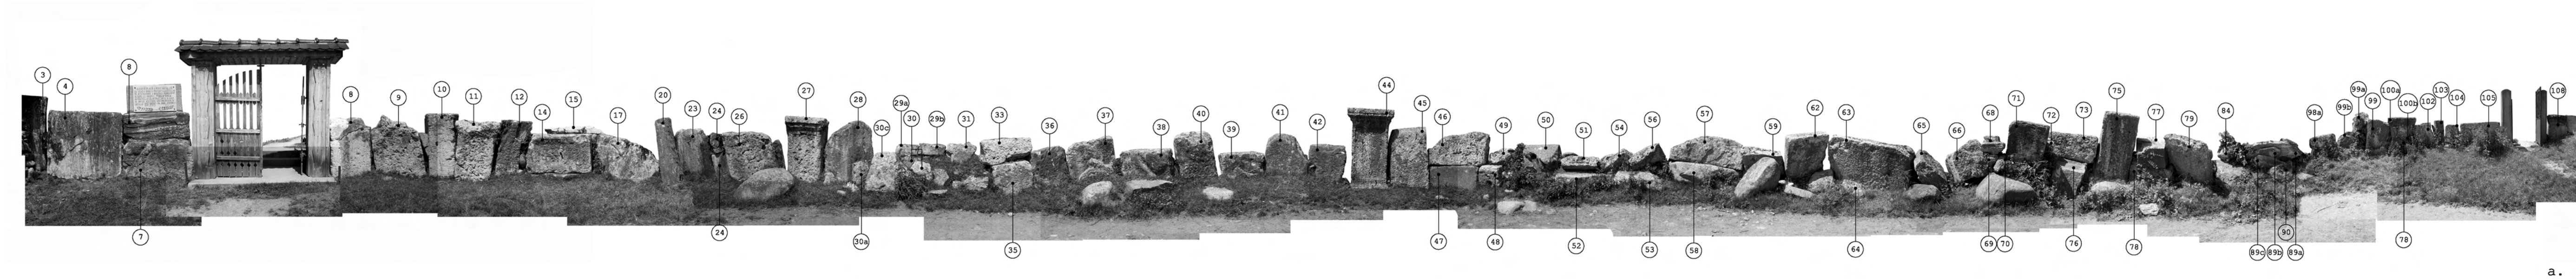
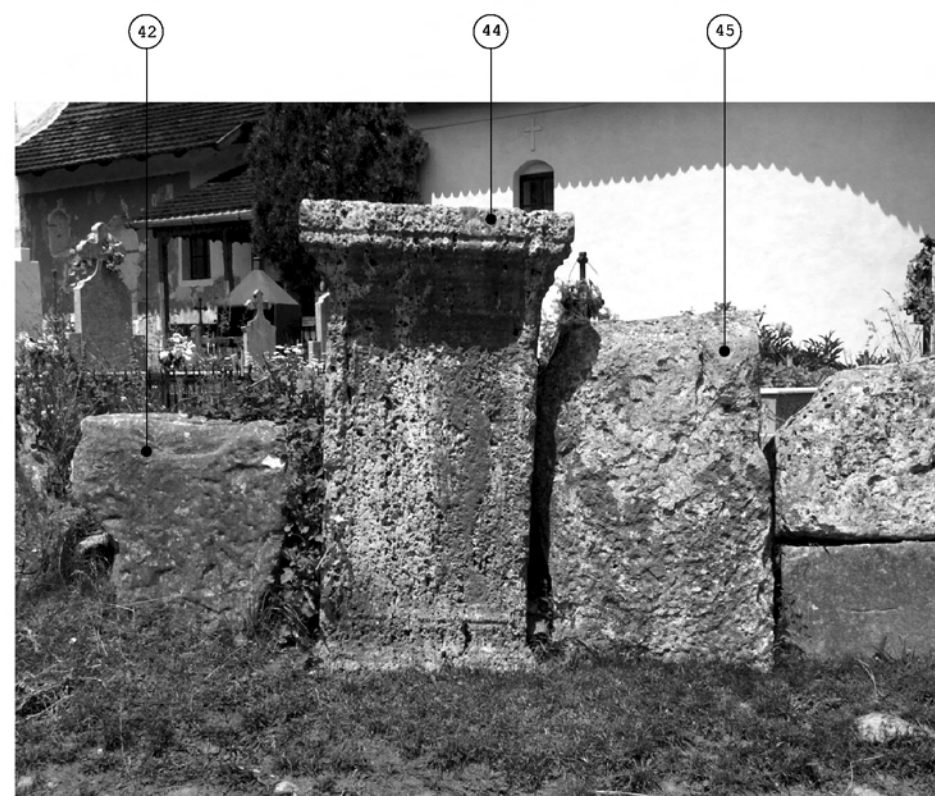
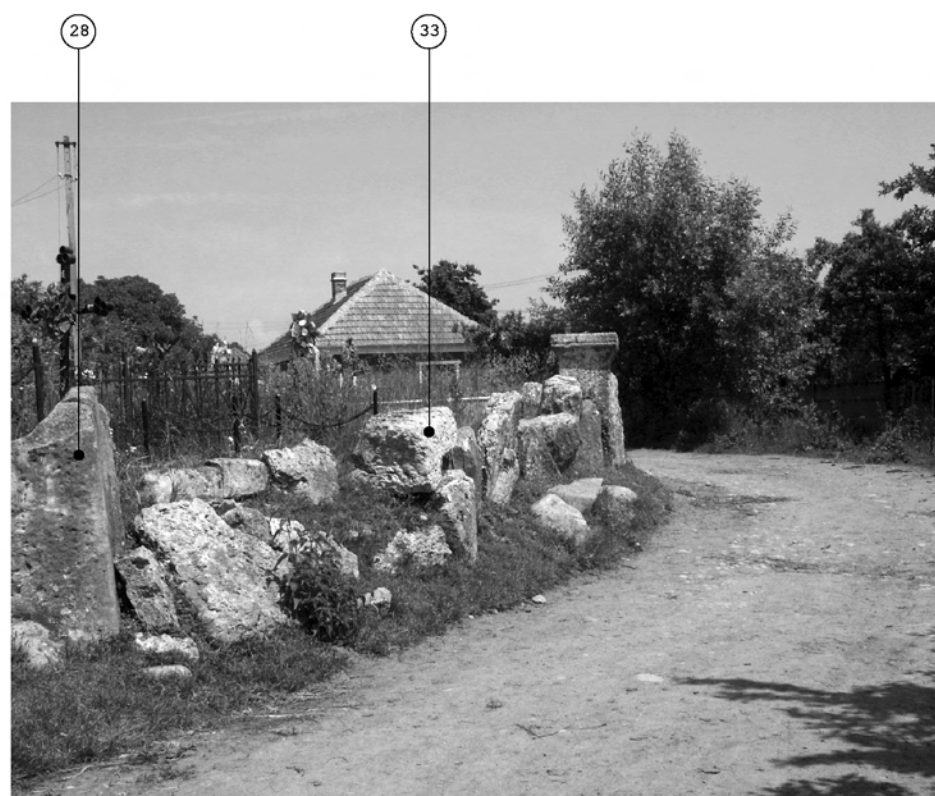
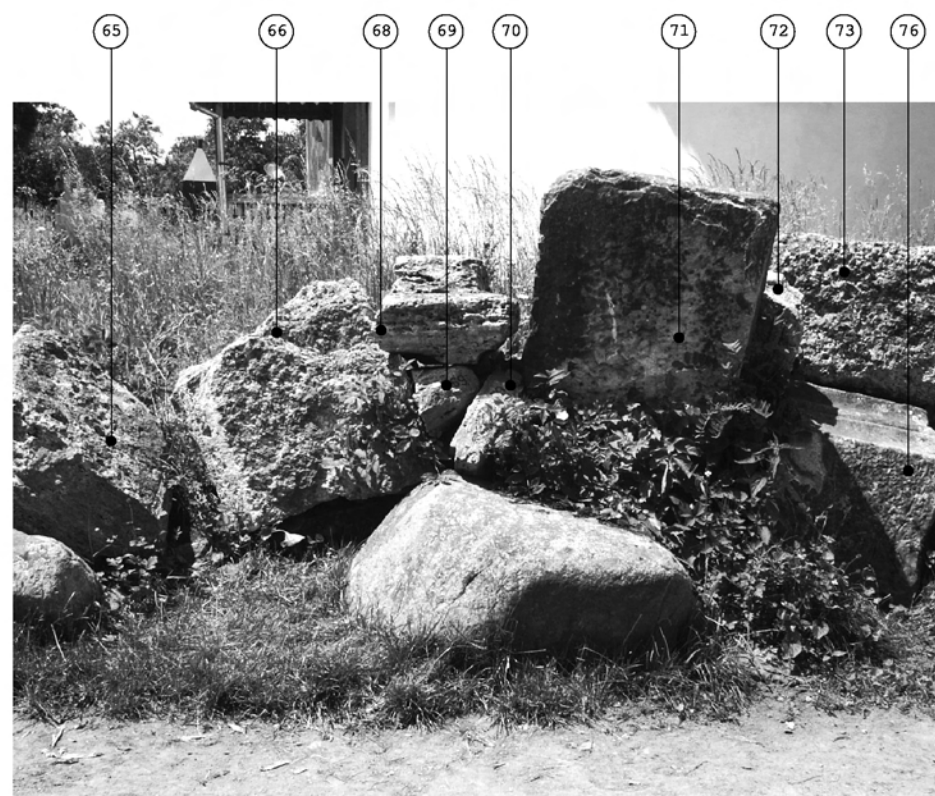
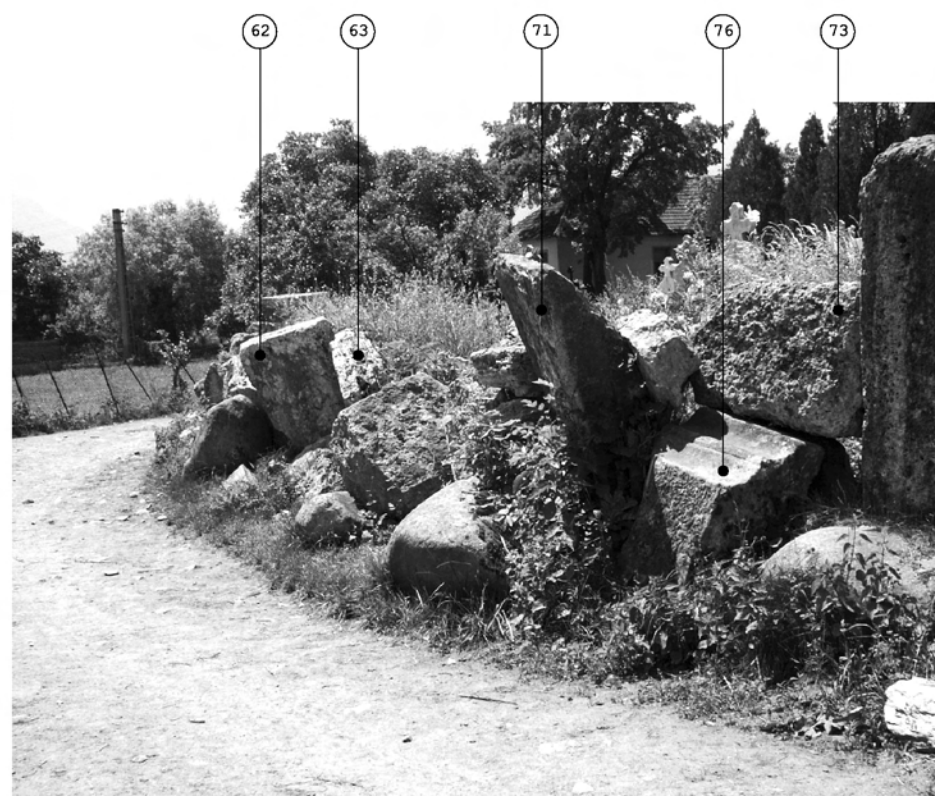
Pl. XXVIII. a. South - east sector view; b. Altar detail inv.no.27; c. View from the main gate (A) towards altar inv.no.27; d. Detail with blocks inv.nos.65-76; e. View from gate (B) towards blocks inv.nos.66, 68, 69, 70, 71, 76 detail
